Geotechnical and Salinity Investigation Proposed Residential Subdivision Development Lot 437 DP 755242 No 1377 Hue Hue Road Wyee NSW

Ref: JC21405A-r2(rev)

September 2021

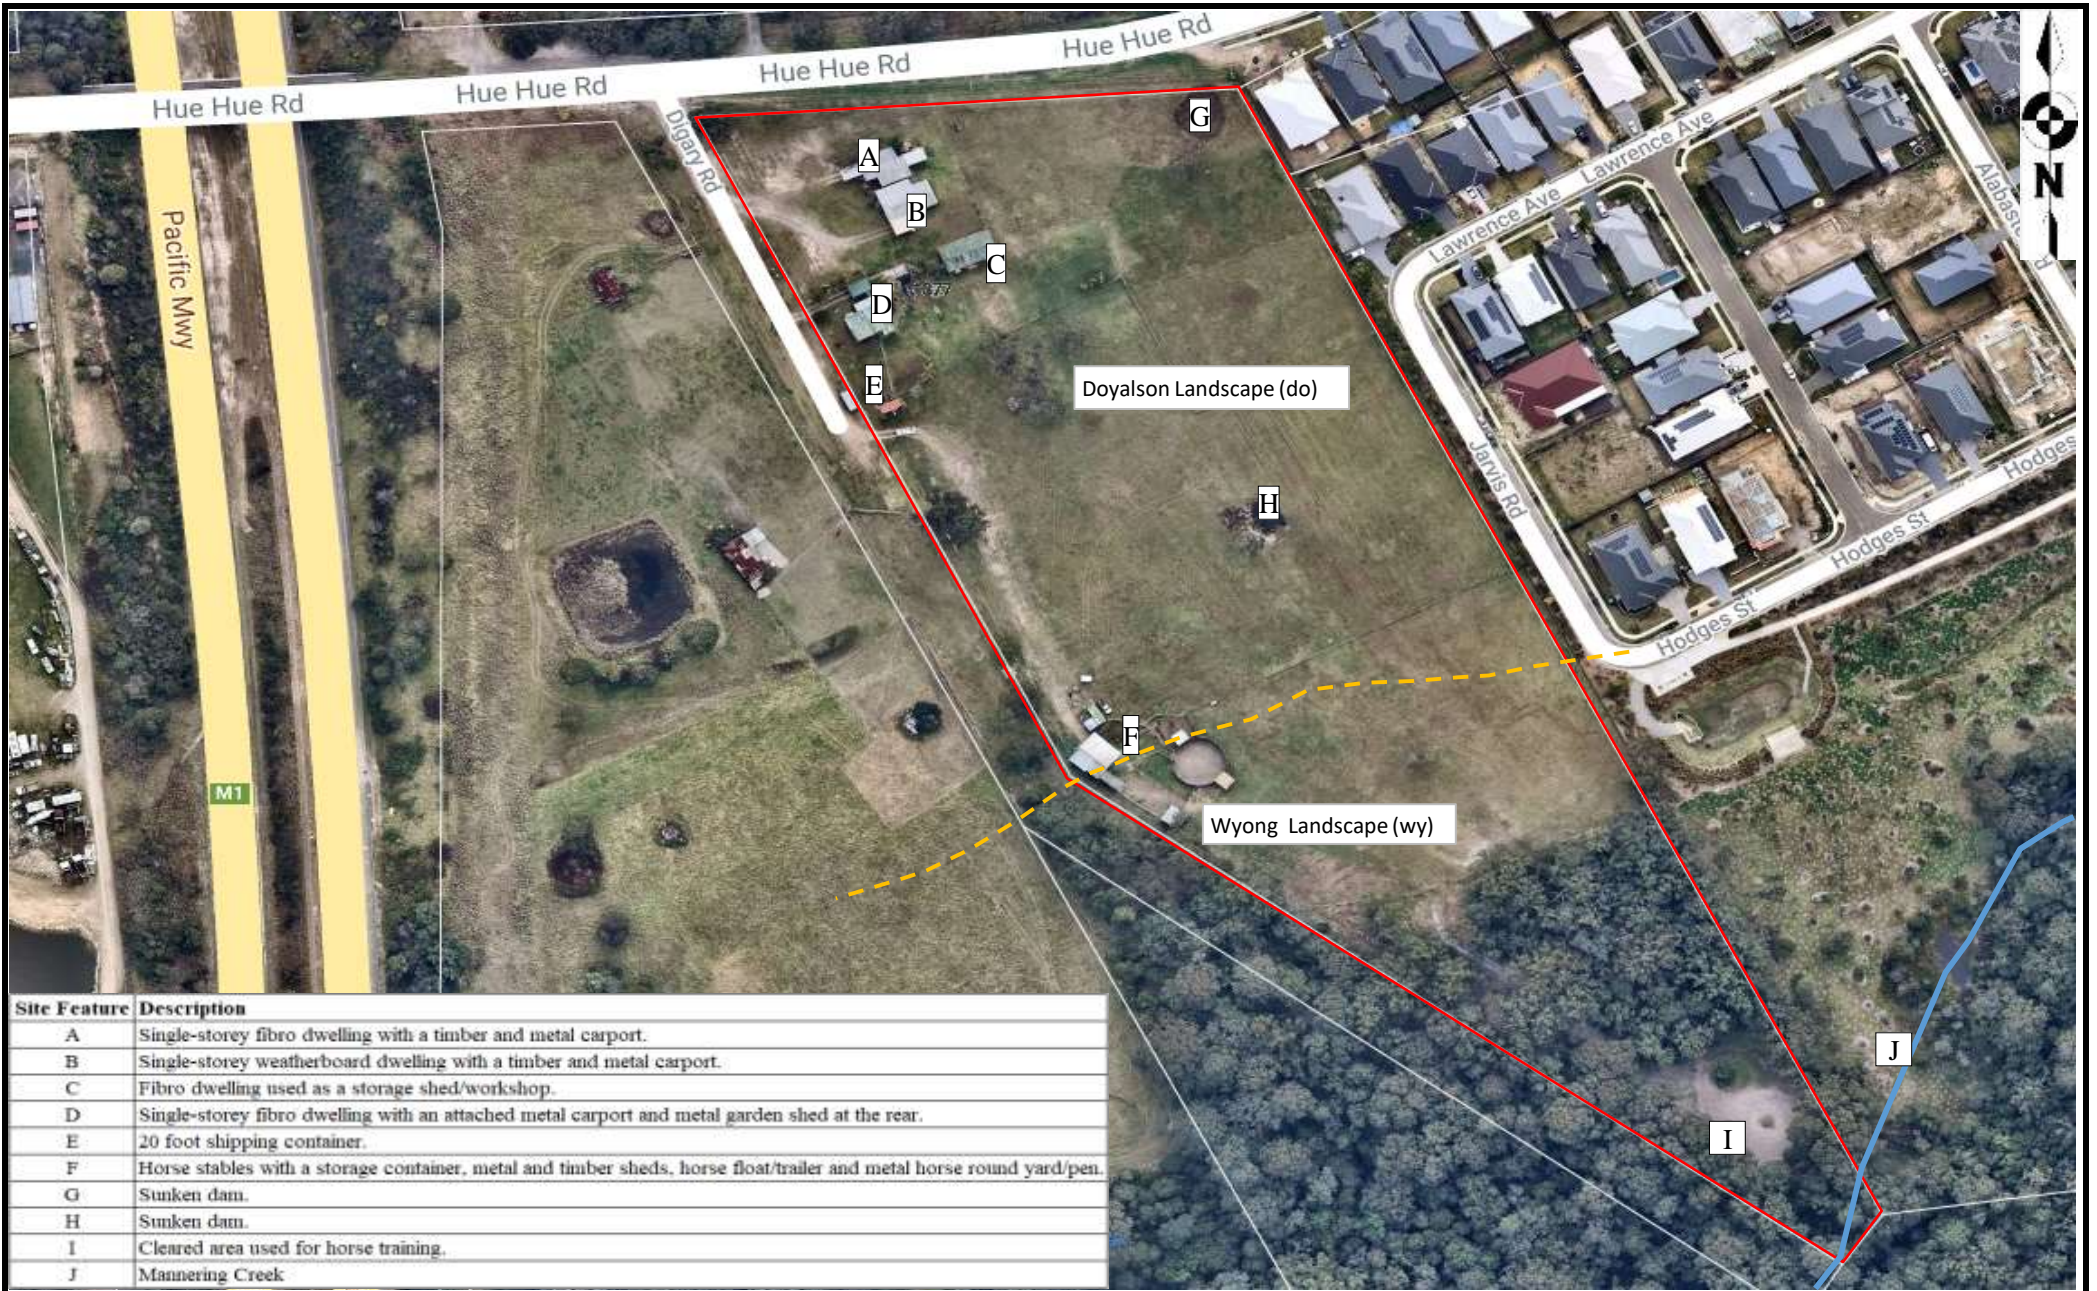
Drawing No: 1

Site Feature	Description
A	Single-storey fibro dwelling with a timber and metal carport.
B	Single-storey weatherboard dwelling with a timber and metal carport.
C	Fibro dwelling used as a storage shed/workshop.
D	Single-storey fibro dwelling with an attached metal carport and metal garden shed at the rear.
E	20 foot shipping container.
F	Horse stables with a storage container, metal and timber sheds, horse float/trailer and metal horse round yard/pen.
G	Sunken dam.
H	Sunken dam.
I	Cleared area used for horse training.
J	Mannering Creek

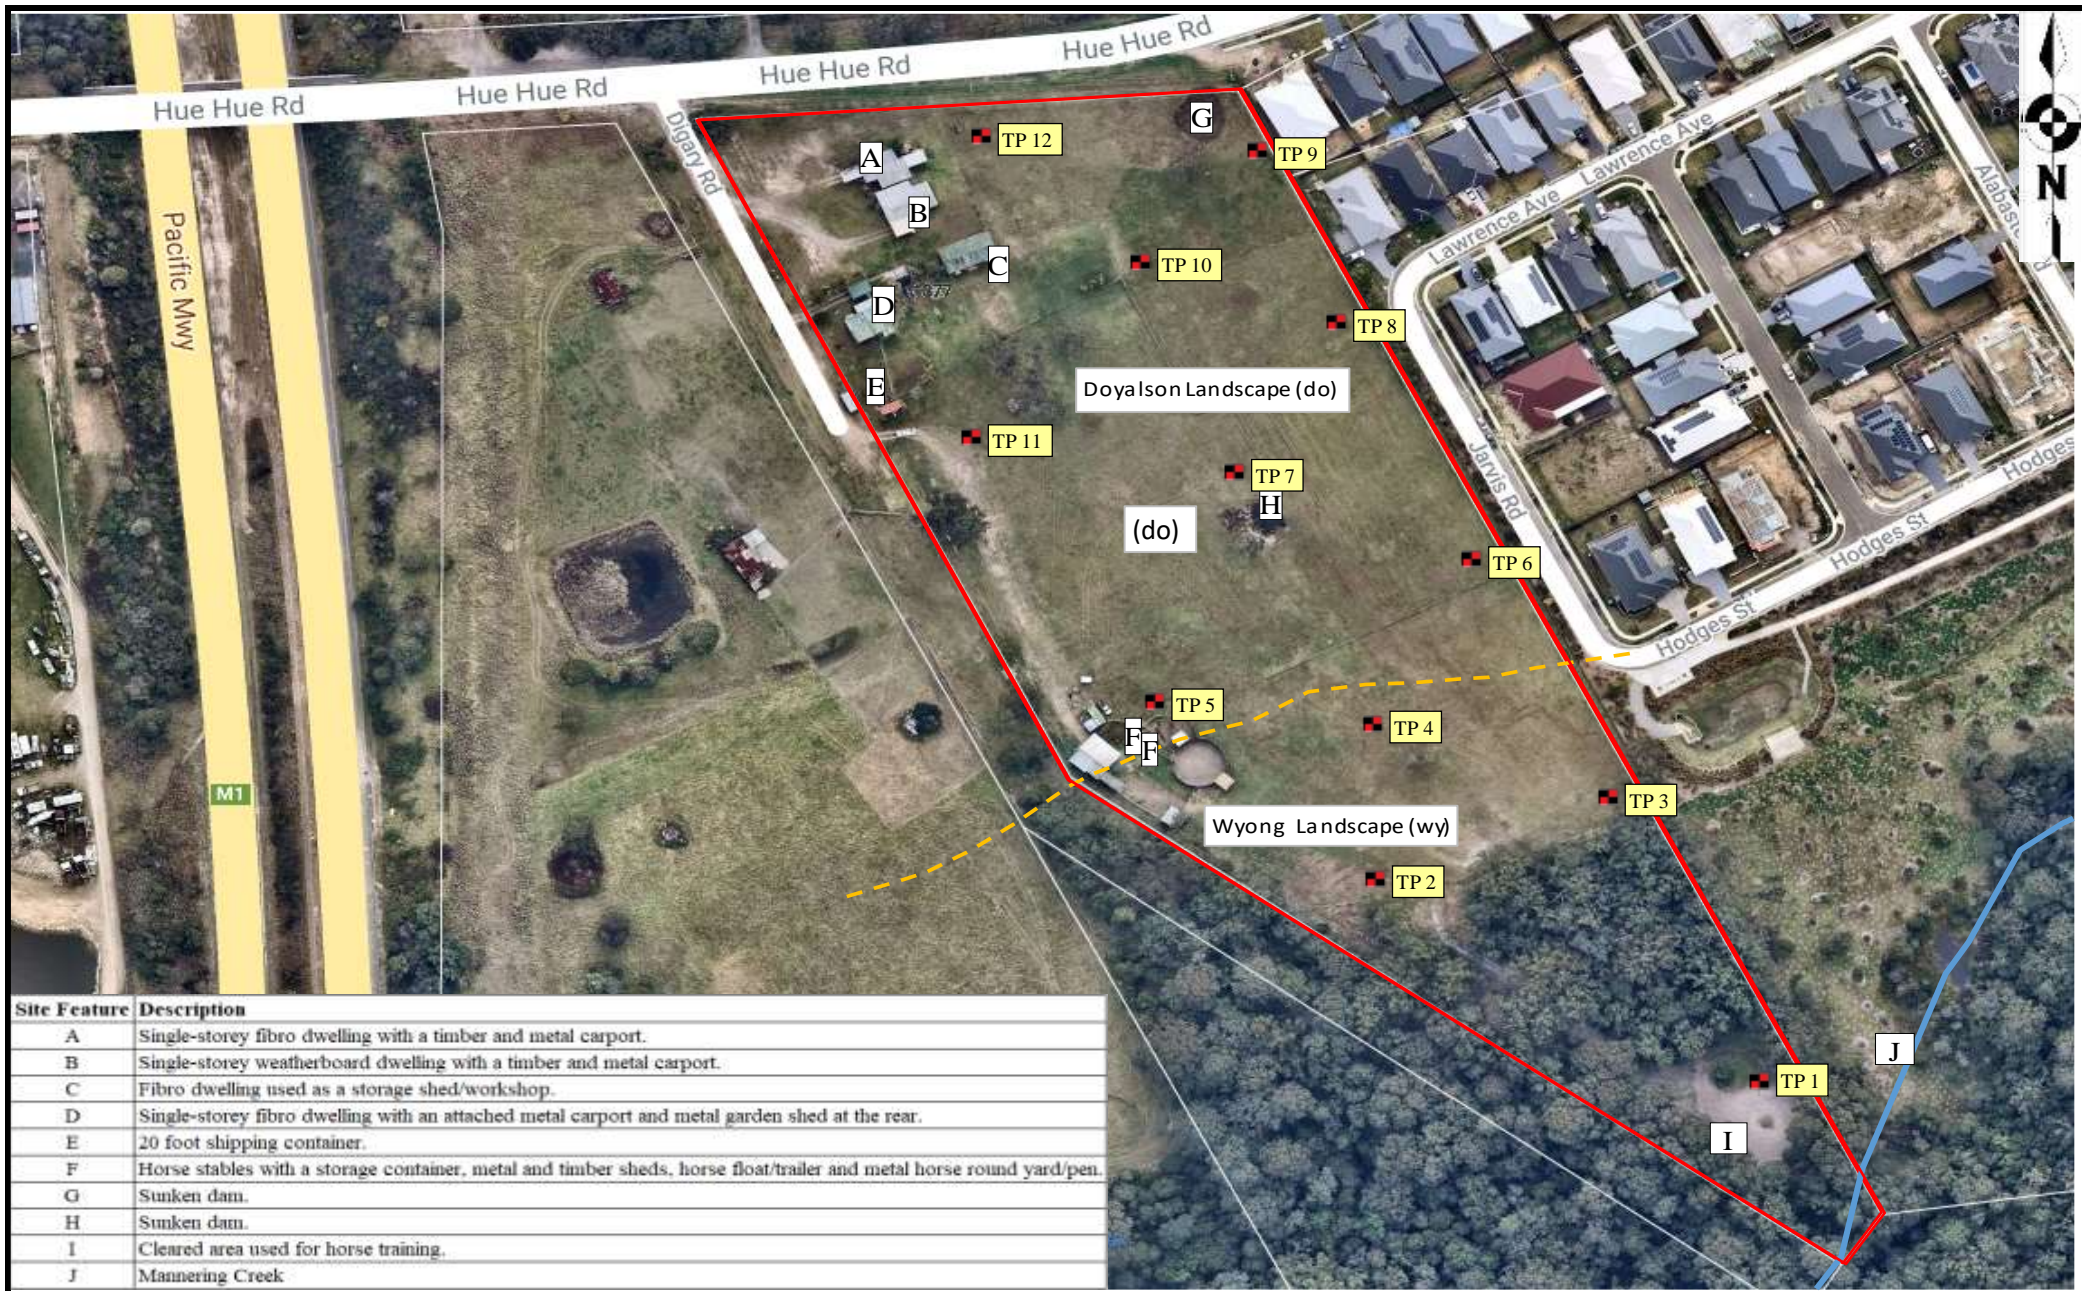
Site Feature	Description
A	Single-storey fibro dwelling with a timber and metal carport.
B	Single-storey weatherboard dwelling with a timber and metal carport.
C	Fibro dwelling used as a storage shed/workshop.
D	Single-storey fibro dwelling with an attached metal carport and metal garden shed at the rear.
E	20 foot shipping container.
F	Horse stables with a storage container, metal and timber sheds, horse float/trailer and metal horse round yard/pen.
G	Sunken dam.
H	Sunken dam.
I	Cleared area used for horse training.
J	Mannering Creek

Legend	
	Test Pit

The test pits were excavated to depths varying from 1.4m to 3.1m below existing ground surface. The test pits were observed for groundwater during and upon completion of the excavation. The field results together with details of the strata encountered are presented in Table A.

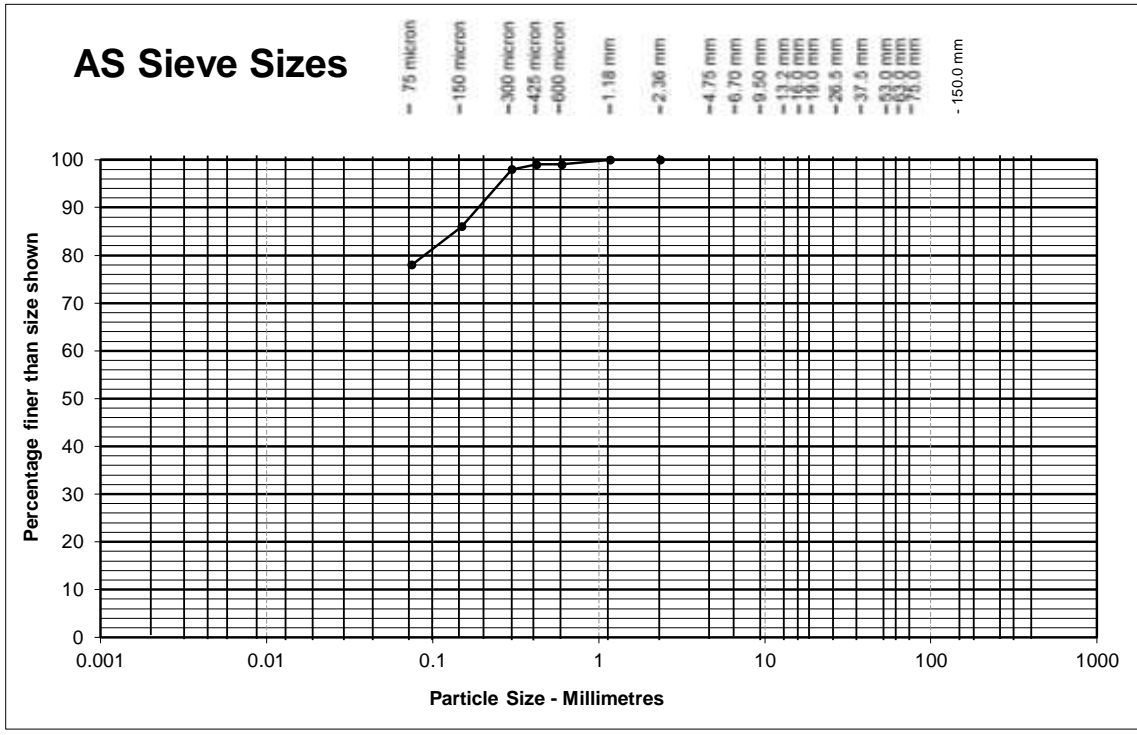
Laboratory Specimen Description:					
Test Method	Test Results	Test Procedure	Test Procedure AS1289 2.1.1, 3.6.1		
Liquid Limit (%)	-	AS 1289 3.1.1	Sieve Size	% Passing	Specification
Plastic Limit (%)	-	AS 1289 3.2.1	150 mm		
Plasticity Index (%)	-	AS 1289 3.3.1	75 mm		
Linear Shrinkage (%)	-	AS 1289 3.4.1	63 mm		
Natural Moisture %	-	AS 1289 2.1.1	53 mm		
Sample History:	-		37.5 mm		
Preparation Method:	-		26.5 mm		
Condition of linear shrinkage:	-		19 mm		
Linear shrinkage mould length:	-		16 mm		
			13.2 mm		
			9.5 mm		
			6.7 mm		
			4.75 mm		
			2.36 mm	100	
			1.18 mm	100	
			600 um	99	
			425 um	99	
			300 um	98	
			150 um	86	
			75 um	78

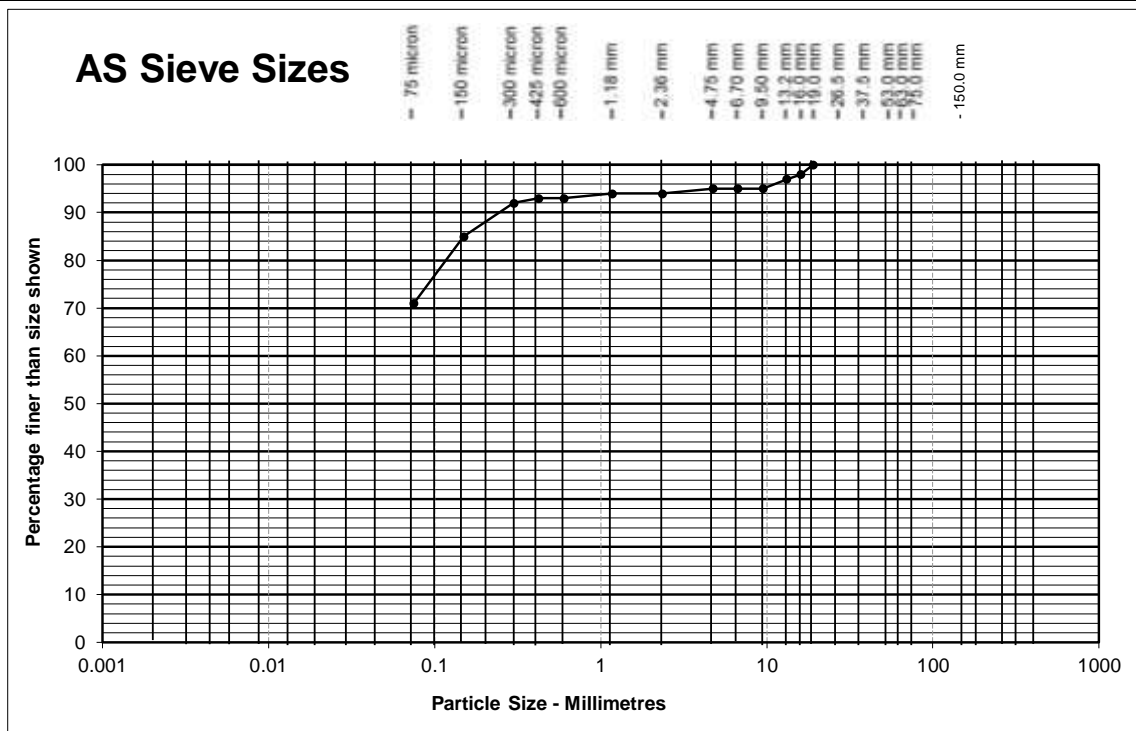
Laboratory Specimen Description:					
Test Method	Test Results	Test Procedure	Test Procedure AS1289 2.1.1, 3.6.1		
Liquid Limit (%)	-	AS 1289 3.1.1	Sieve Size	% Passing	Specification
Plastic Limit (%)	-	AS 1289 3.2.1	150 mm		
Plasticity Index (%)	-	AS 1289 3.3.1	75 mm		
Linear Shrinkage (%)	-	AS 1289 3.4.1	63 mm		
Natural Moisture %	-	AS 1289 2.1.1	53 mm		
Sample History:	-		37.5 mm		
Preparation Method:	-		26.5 mm		
Condition of linear shrinkage:	-		19 mm	100	
Linear shrinkage mould length:	-		16 mm	98	
			13.2 mm	97	
			9.5 mm	95	
			6.7 mm	95	
			4.75 mm	95	
			2.36 mm	94	
			1.18 mm	94	
			600 um	93	
			425 um	93	
			300 um	92	
			150 um	85	
			75 um	71

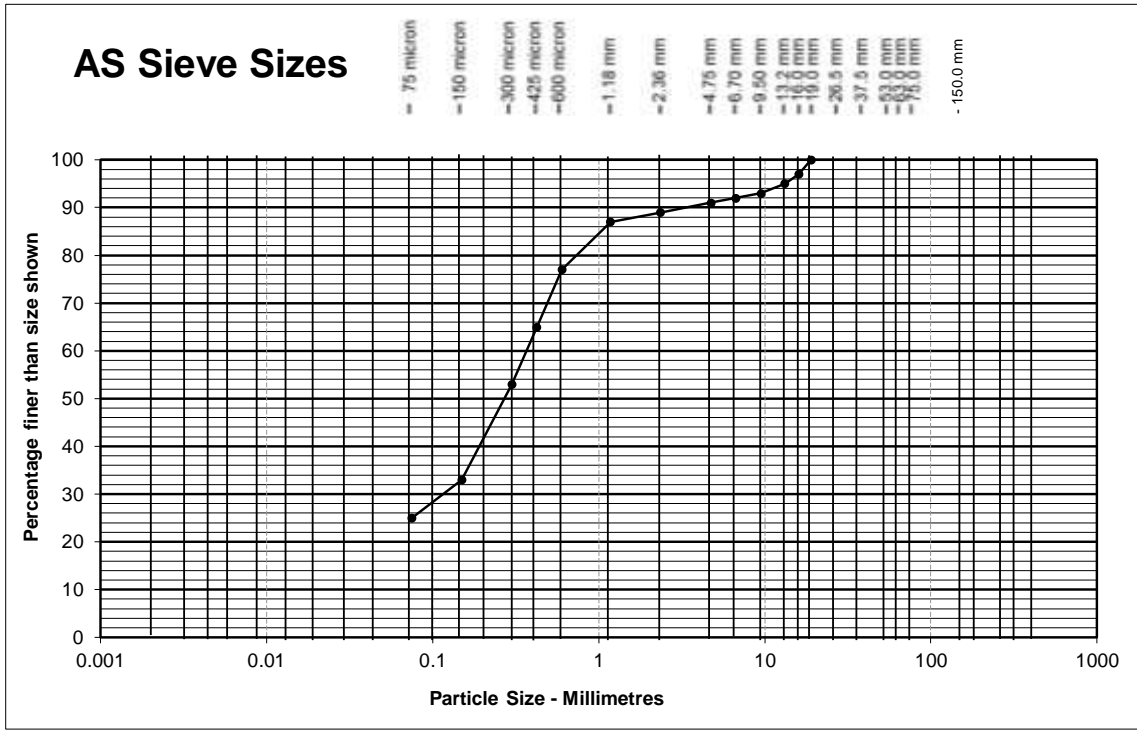
Laboratory Specimen Description:					
Test Method	Test Results	Test Procedure	Test Procedure AS1289 2.1.1, 3.6.1		
Liquid Limit (%)	-	AS 1289 3.1.1	Sieve Size	% Passing	Specification
Plastic Limit (%)	-	AS 1289 3.2.1	150 mm		
Plasticity Index (%)	-	AS 1289 3.3.1	75 mm		
Linear Shrinkage (%)	-	AS 1289 3.4.1	63 mm		
Natural Moisture %	-	AS 1289 2.1.1	53 mm		
Sample History:	-		37.5 mm		
Preparation Method:	-		26.5 mm		
Condition of linear shrinkage:	-		19 mm	100	
Linear shrinkage mould length:	-		16 mm	97	
			13.2 mm	95	
			9.5 mm	93	
			6.7 mm	92	
			4.75 mm	91	
			2.36 mm	89	
			1.18 mm	87	
			600 um	77	
			425 um	65	
			300 um	53	
			150 um	33	
			75 um	25
