Report on Preliminary Site Investigation (Contamination)

Proposed Rezoning 87 Oakdale Road, Gateshead

Prepared for Oakdale Group Pty Ltd

> Project 102219.00 February 2021

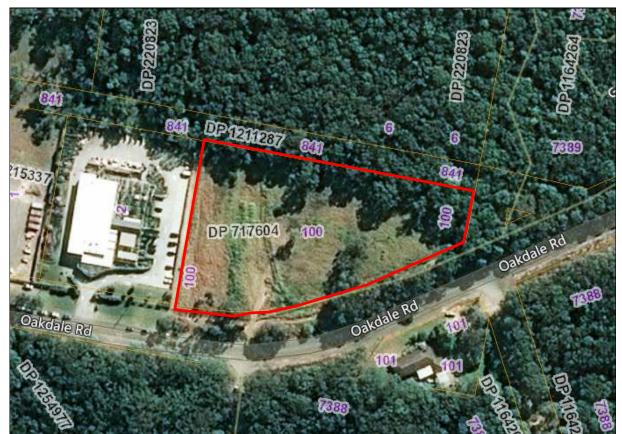
Figure 1: Site Location (site boundary in red)

The site boundary is shown on **Figure 1**.

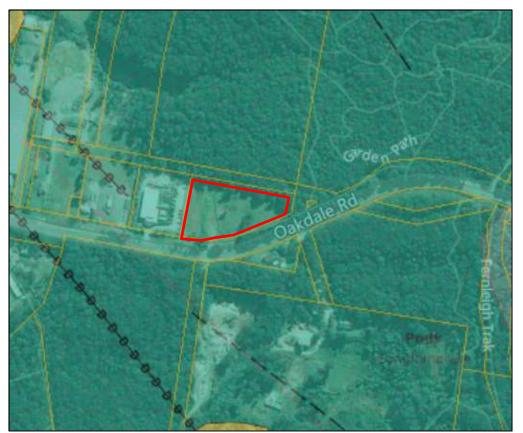
Figure 2: Geological mapping of the site and surrounding areas (site is red polygon)

Published mapping indicates that the site is underlain by the Kahibah Formation which is typically characterised by polymictic conglomerate, sandstone, shale and tuff (refer Figure 2).

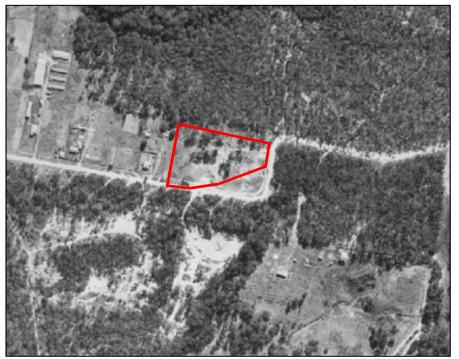
Figure 3: 1966 aerial image (site is red polygon)

Year of Photo	Scale (Colour)	Main Observations
1955	1:30,000 (B&W)	The site is covered with bushland.
1966	1:38,000 (B&W)	The site appears to be a combination of grass covered with some bare earth areas. Scattered trees are visible (refer Figure 3).
1976	1:25,000 (colour)	The site is grass covered with some scattered trees.
1984	1:40,000 (B&W)	Grass covered with some scattered trees. It is noted the alignment of Oakdale Road has altered since the 1976 image.
1993	1:25,000 (colour)	The site is in a similar condition to the 1984 image.
1996	1:16,000 (colour)	The site is in a similar condition to the 1993 image.
10/1/2007 Google Earth	Not to scale (Colour)	The site is grass covered and appears to have a track (possibly motorbike track) visible in the image.
28/9/2009 Google Earth	Not to scale (Colour)	It appears that the site has been levelled/cleared, with brown surface soil visible in the image.
17/9/2010 Google Earth	Not to scale (Colour)	Fill appears to have been placed in the western area of the site (refer Figure 4). It appears that the site may have been used for temporary storage.

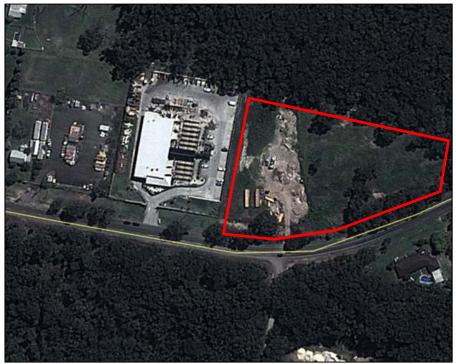
Figure 4: Google Earth image taken 17 September 2010, showing storage on site and fill placed in western area

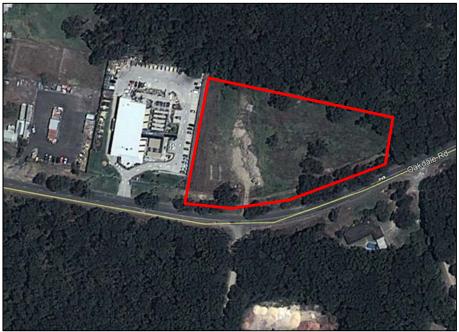
Figure 5: Google Earth image taken 22 October 2012 (showing fill has been placed on western part of site

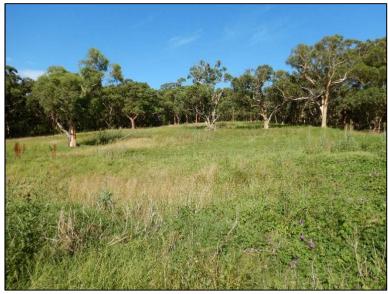
Figure 6: Looking east from entrance of site

- The majority of the site is a cleared paddock, which slopes down to the west and contains a few scattered trees (refer Figure 6 and Figure 7);
- Dense grass was present over the bulk of the surface;

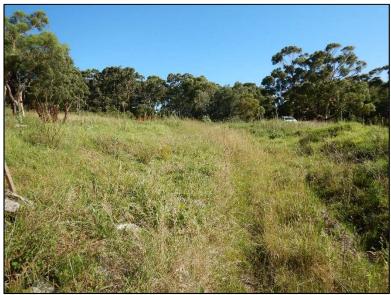
- Some fill has been placed within the south-western part of the site (refer Figure 8) based on the observed landform;
- Based on observations at the surface and the site topography, the fill generally forms a relatively flat area which extends from the gate adjacent to Oakdale Road and covers an area of approximately 50 m by 30 m (refer Drawing 1, Figure 8 and Figure 9);

Figure 8: Looking south from western-central area of the site (note fill stockpiles)

Therefore, it is recommended that additional investigations are undertaken prior to development / construction being undertaken on the site to better assess the contamination status and extent of fill/stockpile material within the site. Further sampling and testing on fill materials including sieving for ACM is recommended to confirm remediation requirements (if any).

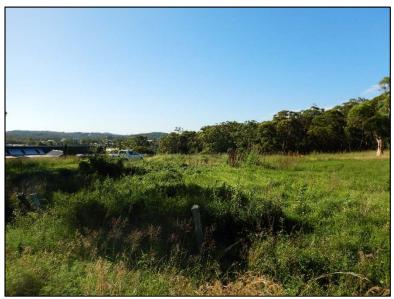
Figure 9: View looking north from near main entrance gate of filled area

• The depth of fill appears to increase to the south although it is anticipated to be highly variable with a number of semi-detached stockpiles present within this area;

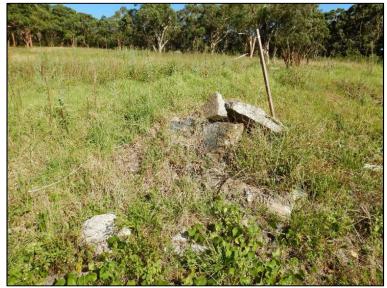
• Concrete and steel was exposed in some locations (localised stockpiles) across this area of the site (refer Figure 10);

Figure 10: Concrete pieces and metal exposed in one of the stockpiles present on the site

It is noted that the concrete was generally encountered within stockpiles at the surface.

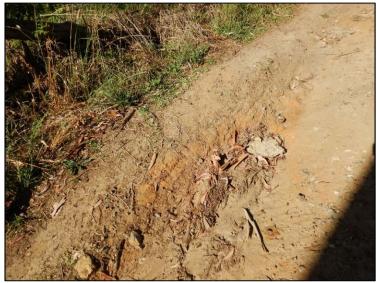
• Residual clay soils were exposed within an existing access track along the southern boundary of the site (refer Figure 11);

Figure 11: Residual clay soils exposed in access track along southern boundary of site

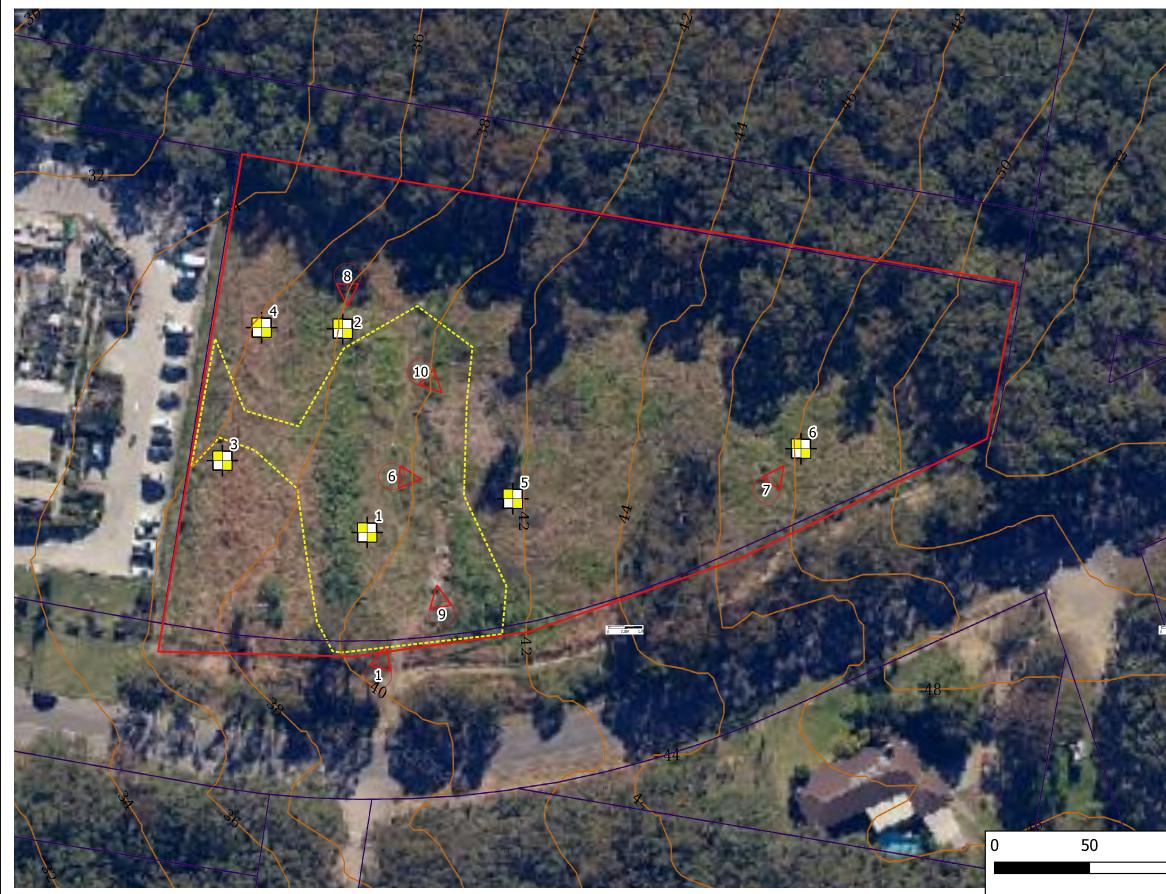
Drawing 1 – Test Location Plan

The main features and observations made of the site during the inspection are discussed below. The location and orientation of the figures below are also shown on Drawing 1:
