Report on Desktop Geotechnical Assessment

Raffertys Resort

81022062-001.1

24 February 2022

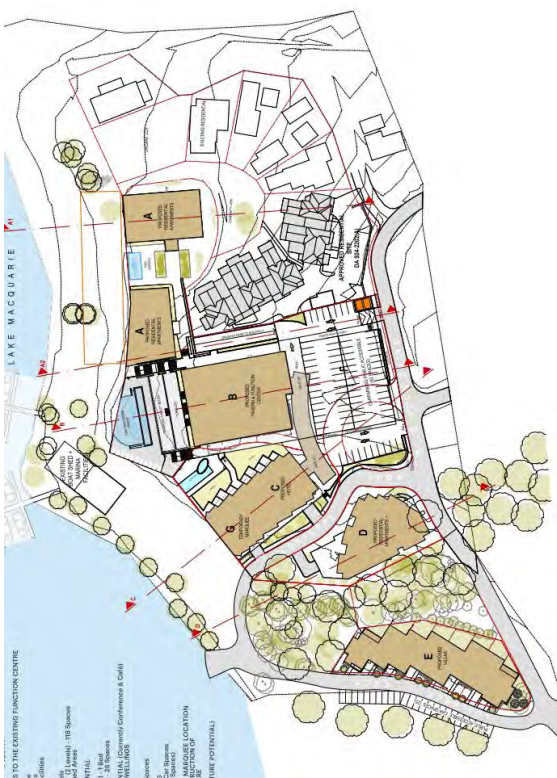
Figure 2-1 Proposed Development Layout – EJE Architecture Drawing A5 (North up Page) [1]

The proposed development and existing layout at the site are depicted below in Figure 2-1 and Figure 2-2. Additional site observations are discussed in Section 5 of this report on the basis of a site walkover.

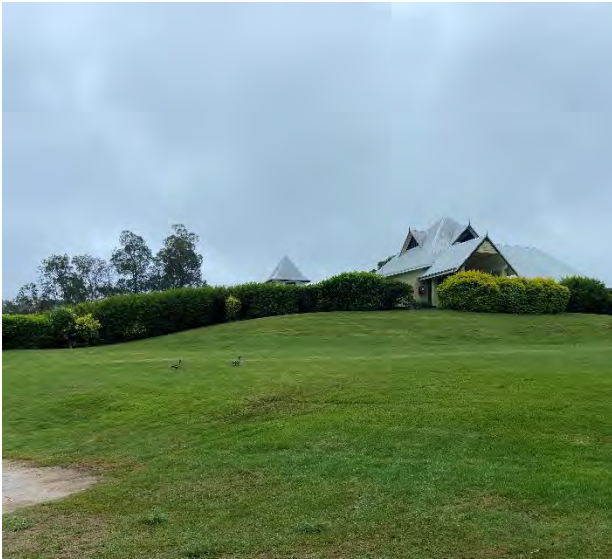
Figure 5-1 Photo of Fill Embankment and Batter Slopes (Facing North to North-East)

- > An existing structure was noted within the proposed Tavern and Function Centre envelope.
- > A fill embankment in the order of 2 m high was noted in the envelope, evidently constructed to provide a level building platform for the existing structure given the natural west facing slopes. Consequently, it is likely the eastern portion of the structure is founded in cut to on-grade with minor filling anticipated.
- > Batter slopes associated with the embankment were noted to slope generally west towards Lake Macquarie (Figure 5-1) at approximately 2H:1V.

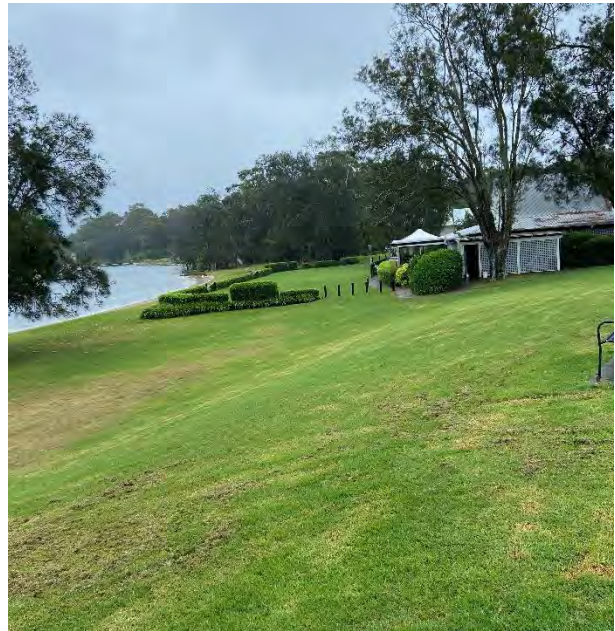
Figure 5-2 Photo of Fill Batters and area of Proposed Site A – Apartment Buildings (Facing North)

- > An existing single storey structure and pool facility is situated within portions of the proposed Site A envelopes.
- > Fill batters associated with the existing function centre to the south-east were noted to encroach the proposed envelope of the southernmost apartment building (Site A).
- > Semi-mature to mature trees were also noted within or close proximity to the envelopes of the Site A apartment buildings.

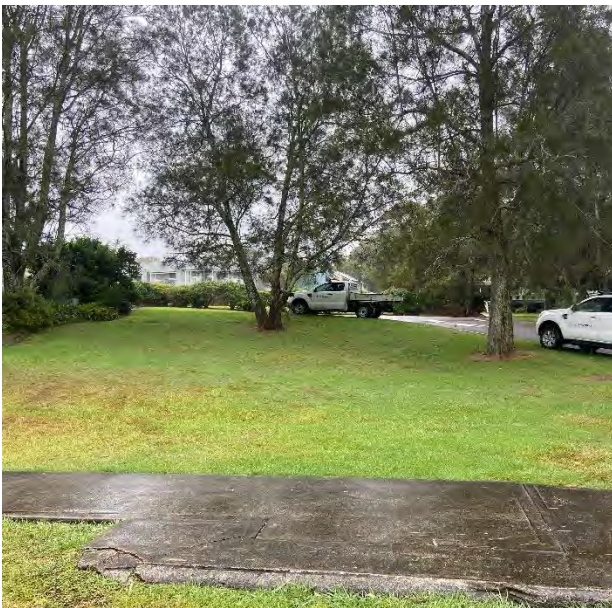
Figure 5-3 Photo of Site C area (Facing East).

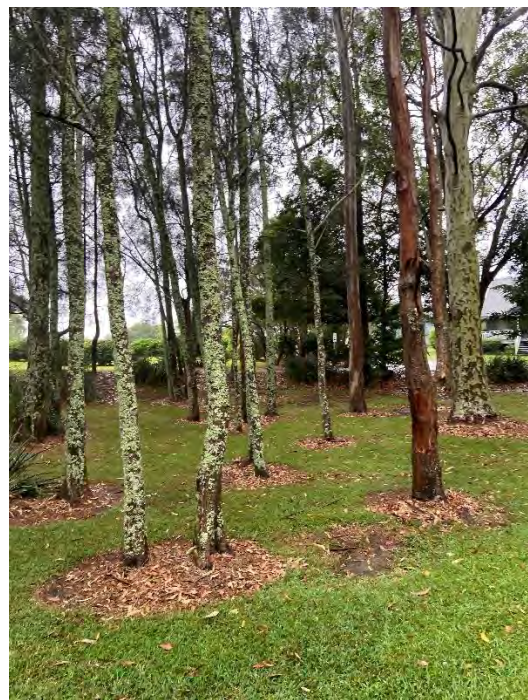
Figure 5-4 Photo of trees within envelope of proposed Site D (Facing East).

- > Apartment Building Site D is likely to be on natural soils with potential minor filling based on surrounding topography associated with road construction.
- > A significant amount of semi-mature to mature trees were noted in the proposed building envelope that would require removal.

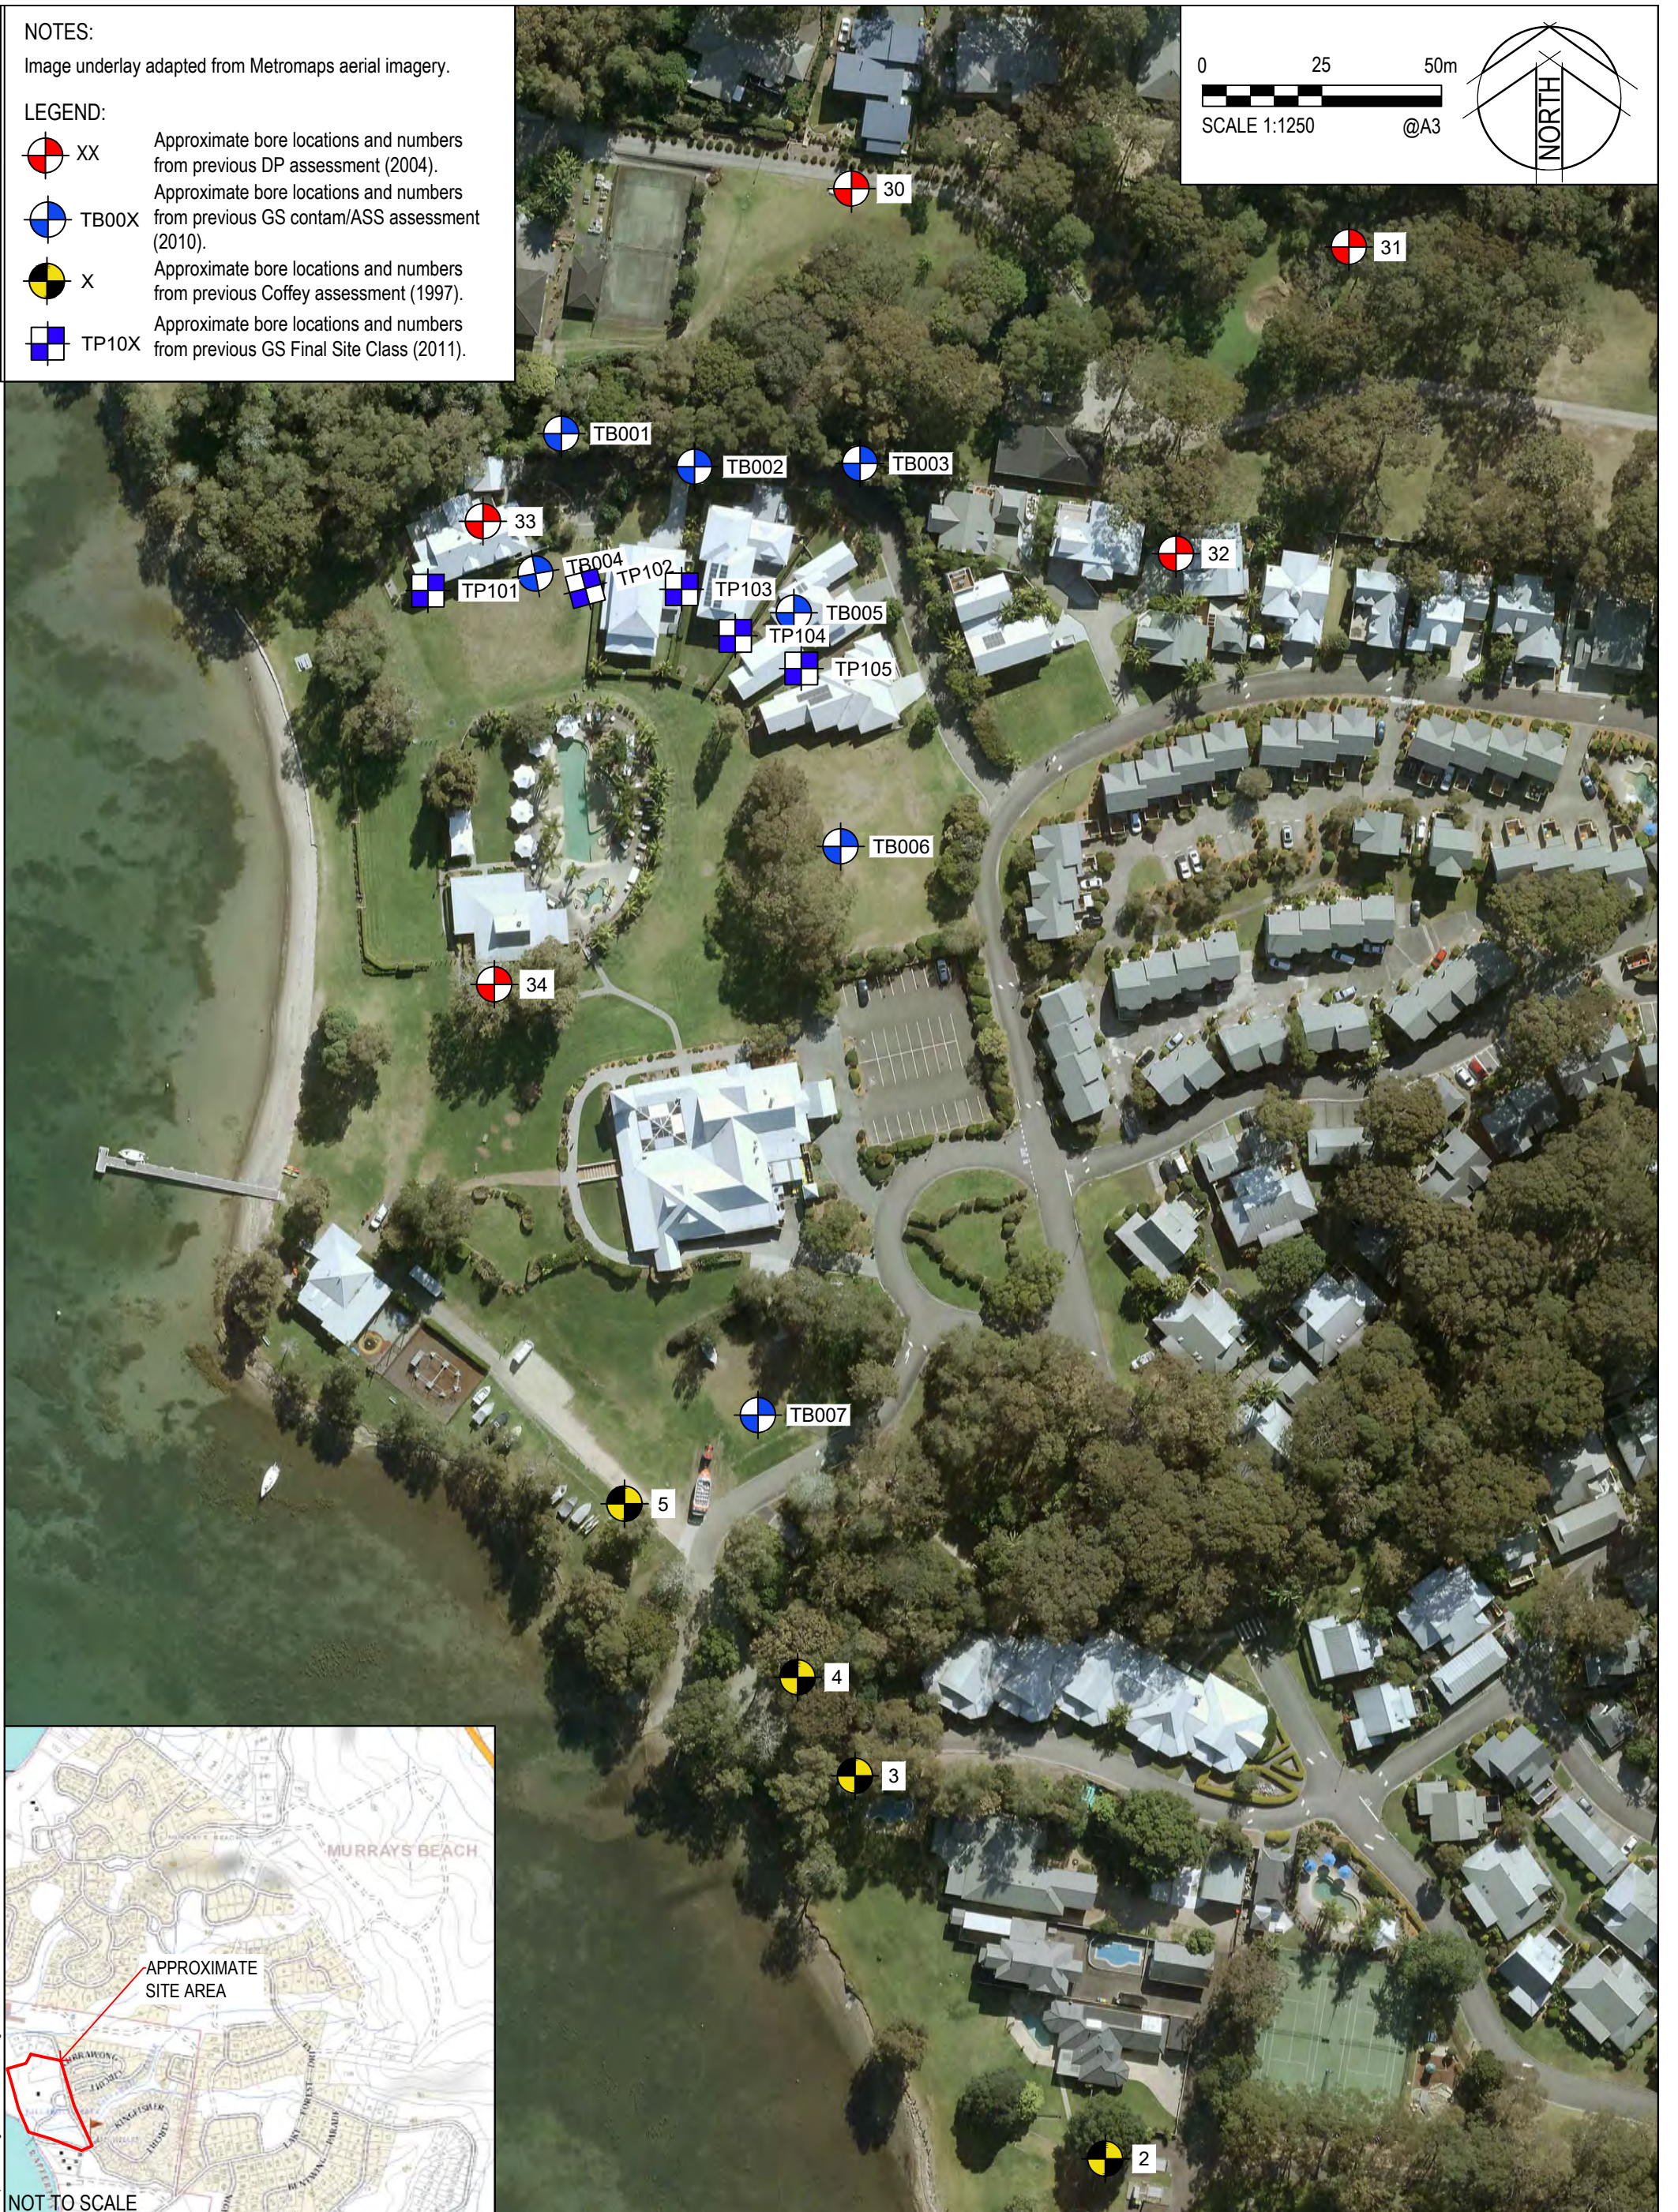
TP10X Approximate bore locations and numbers from previous GS Final Site Class (2011).
