Remedial Action Plan

1 Progress Road, Mount Hutton, NSW, 2290

Report 66242

Issued October 19th, 2023

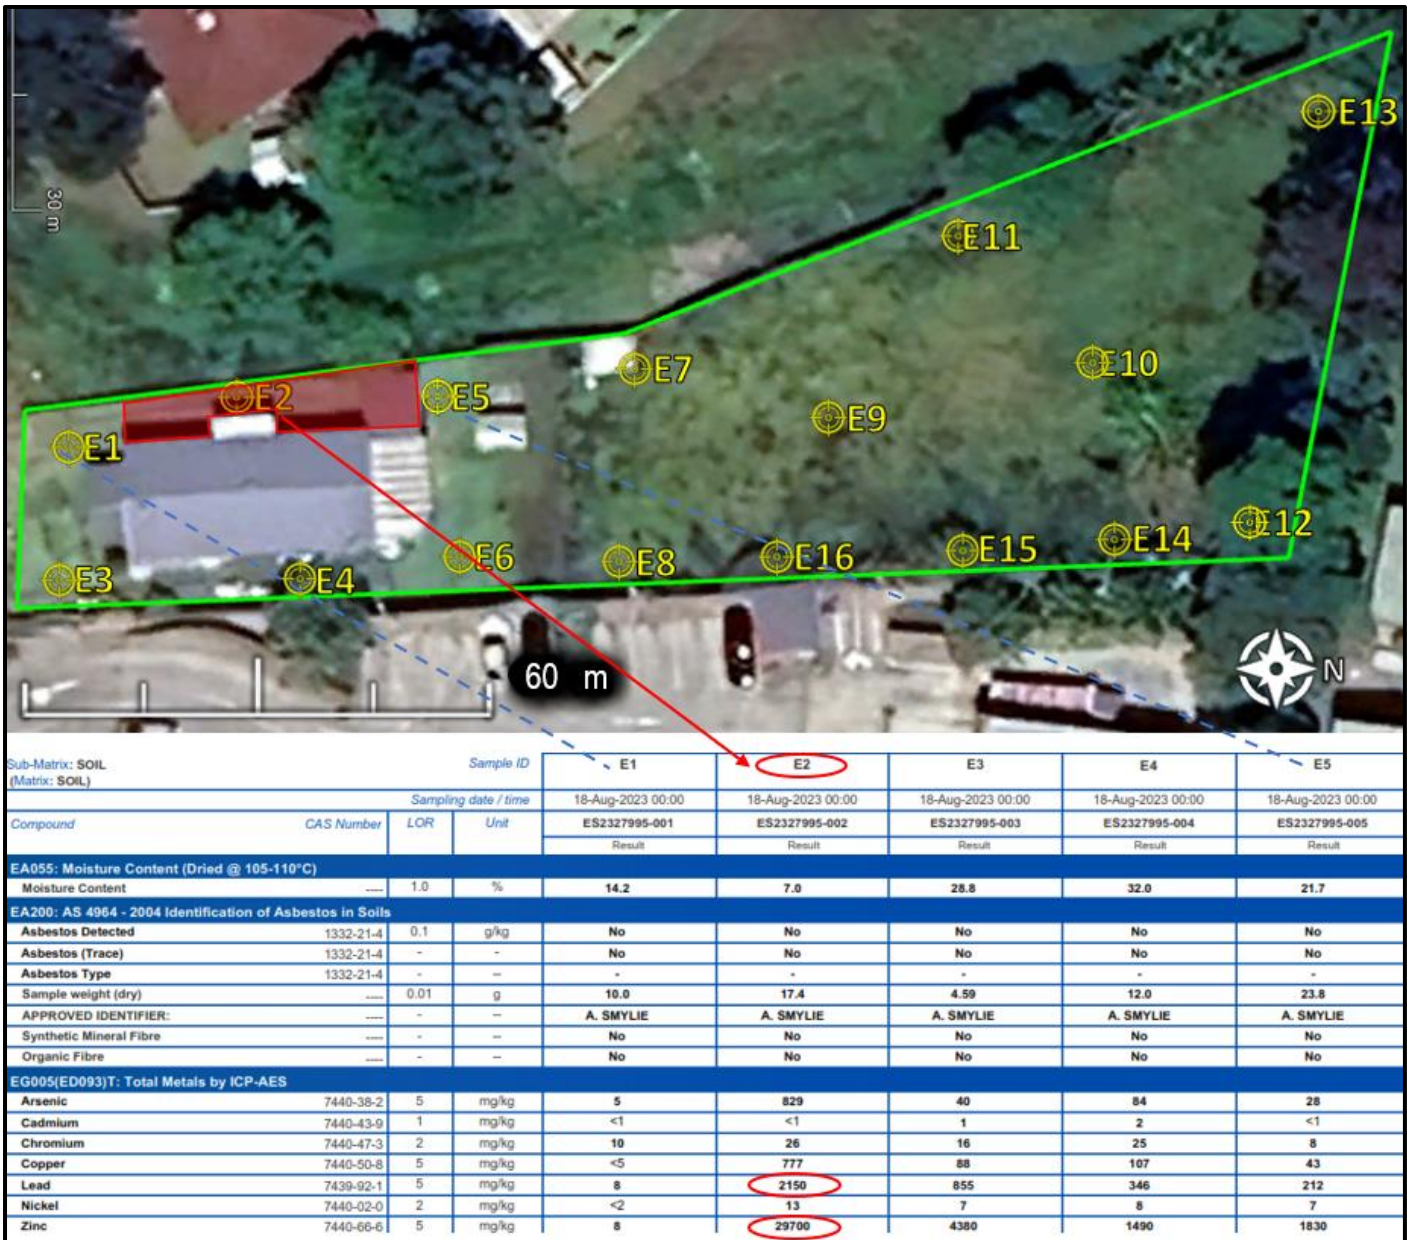
Figure 1. Top image shows sampling areas indicated by yellow alphanumeric labels and targets. The red section highlights an approximation of the remediation area. The red arrow leads to an excerpt of the laboratory certificate of analysis that shows sample E2 yielded levels of lead and zinc that exceed HILs A, and lead that exceeds HILs D (compare with Figure 2). Blue dashed lines indicate samples (E1 and E5) that were used to delineate the expected extent of the remediation area, as they returned contamination levels below ASC NEMP thresholds.

Laboratory results showed that just one sample, E2, obtained from the drive-way next to the house contained quantities of metals that exceed ASC NEPM health investigation levels (HILs): lead (Pb = 2150 mg/kg) and zinc (Zn = 29,700 mg/kg; see Figure 1).

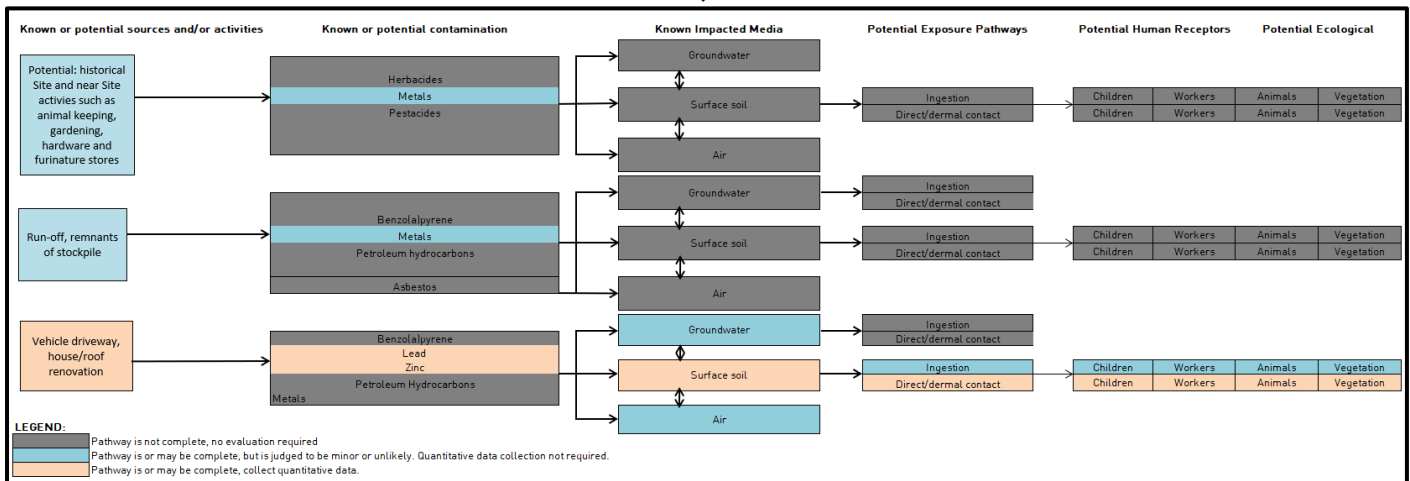
Figure 3. A visualisation of the Conceptual Site Model, revised from the DSI.

CSM	Description
Potential Primary Sources of Contamination	-Historic activities on and around the Site (e.g., agricultural). -Metal/fence work/welding. -Roof renovation.
Known Secondary Sources of Contamination	-Surface soil in the driveway area.
Known Media Affected	-Soil.
Potential Transport Mechanisms	-Surface runoff. -Wind. -Vehicular movements (heavy tires churning and moving top soil).
Potential Exposure Routes	-Direct contact with soil. -Ingestion from soil/plants.
Potential Receptors	-Humans (residents, visitors, workers). -Local fauna and flora.
Potential Exposure Pathways	-Soil to human (e.g., during construction work, gardening, etc.). -Soil to plants to human. -Airborne contaminants to human (especially asbestos inhalation).

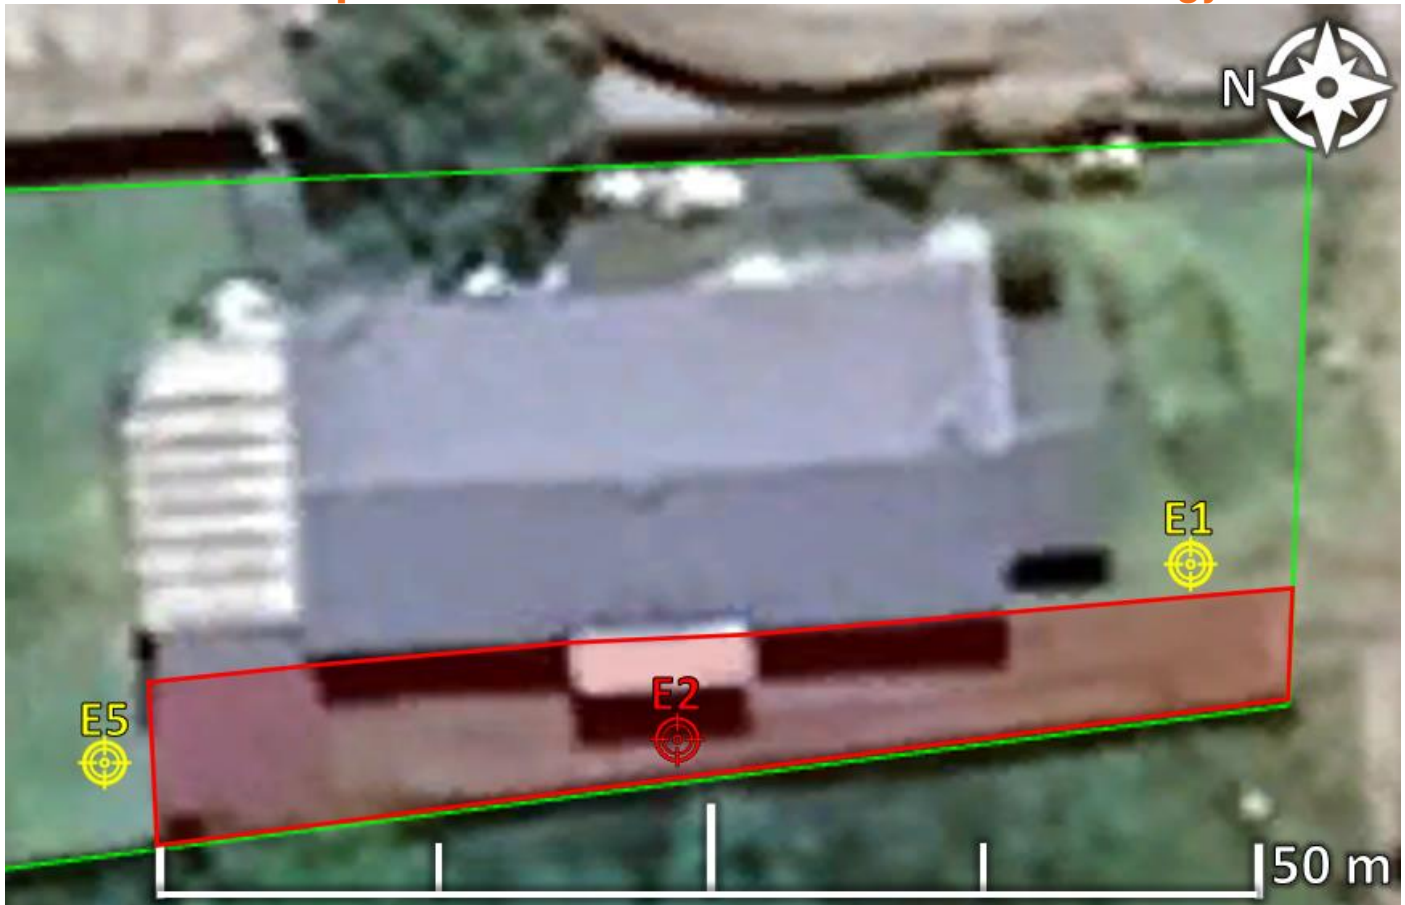
Figure 4. Satellite imagery of the Site with the remediation area in red. The red target and red label E2 indicate where the contaminated sample was obtained. The red boxed area indicates where excavation work is recommended to occur. The yellow targets and alphanumeric labels (E1 and E5) are areas where sampling did not find contamination to exceed HIL thresholds. Sample depths for E1, E2, and E3 were taken at 2 m, 30 mm, and 150 mm, respectively. Green outline indicates the approximate lot boundary. Image adapted from Google Earth 2023.

- Demarcate and cordon off the area of contamination as indicated in red on Figures 4 and 5.
- Remove concrete driveway slabs.
- Excavation of surface soil to a depth of approximately 200 mm. If possible, soil beneath the deck should also be removed to help reduce the risks of potential residual contamination.

Refer to Figures 4 and 5 for the designated soil excavation and replacement areas.
