CM9 Ref. SCSPF24/160  
June 2025

## Blacksmiths Beach

### Dune Management Plan

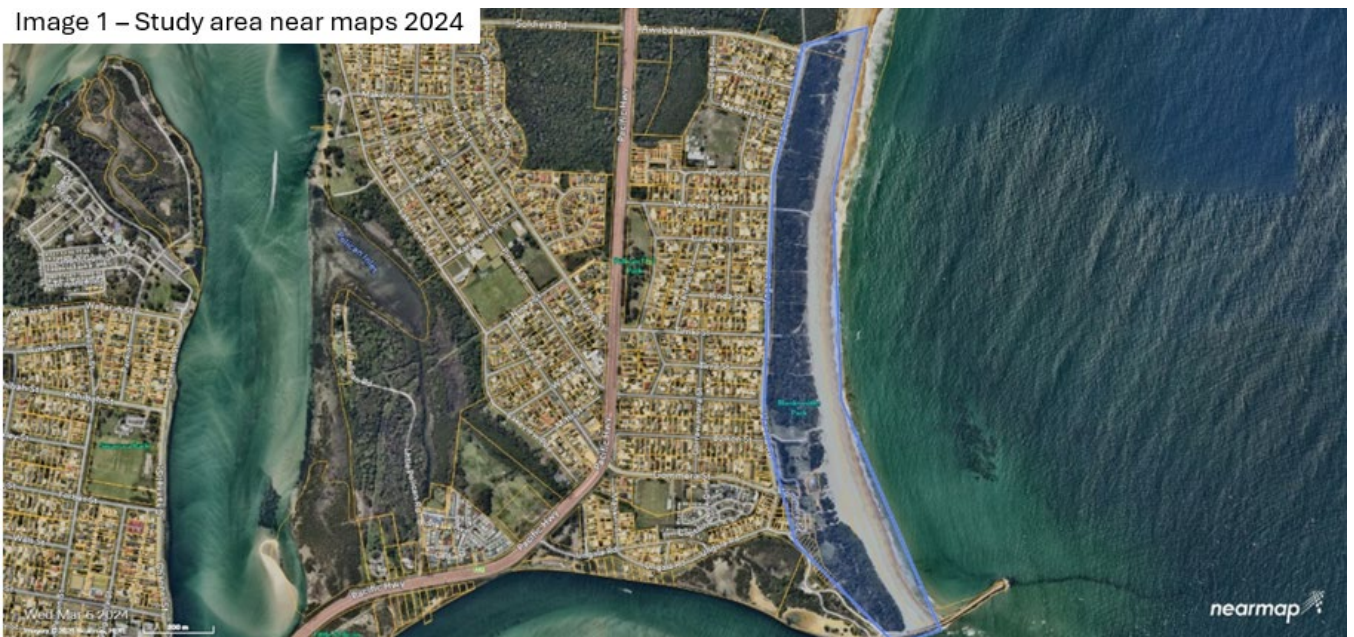
Image 1 – Study area near maps 2024

SCS has been engaged by (LMCC) to develop a Dune Management Plan for Blacksmiths Beach (study area, Image 1).

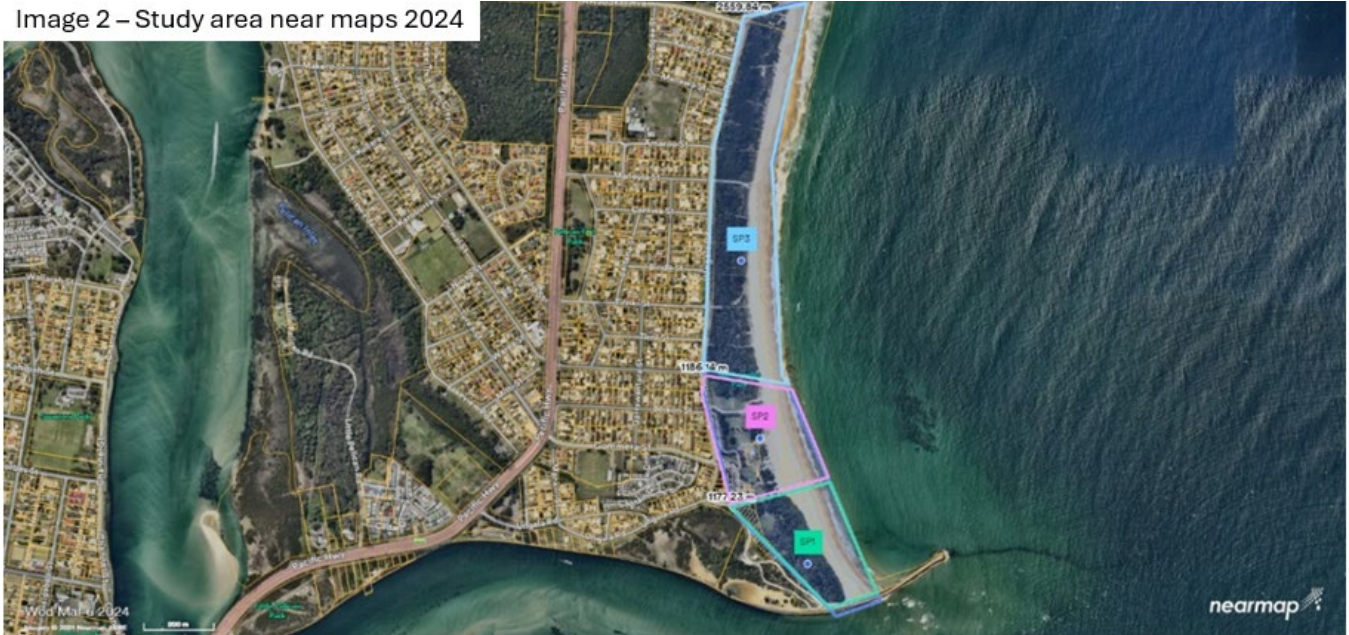
Image 2 – Study area near maps 2024

The dune conditions and targeted management strategies vary within the study area, therefore the study area will be broken up into three separable portions, pictured below.

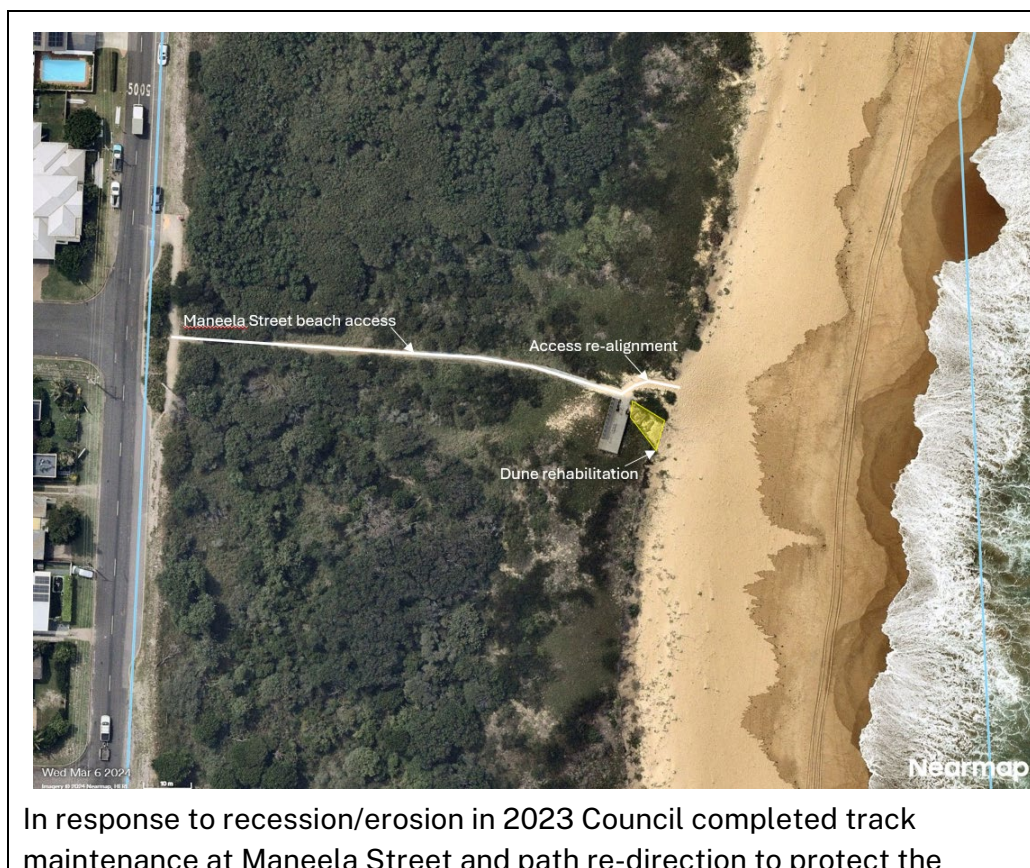
dunes and provide a safe access. The works re-aligned the access and infilled a blow out with beach scraping activities and straw bales. The previous access was originally perpendicular to the beach front, before migrating to the south east and now successfully orientated to the north east.

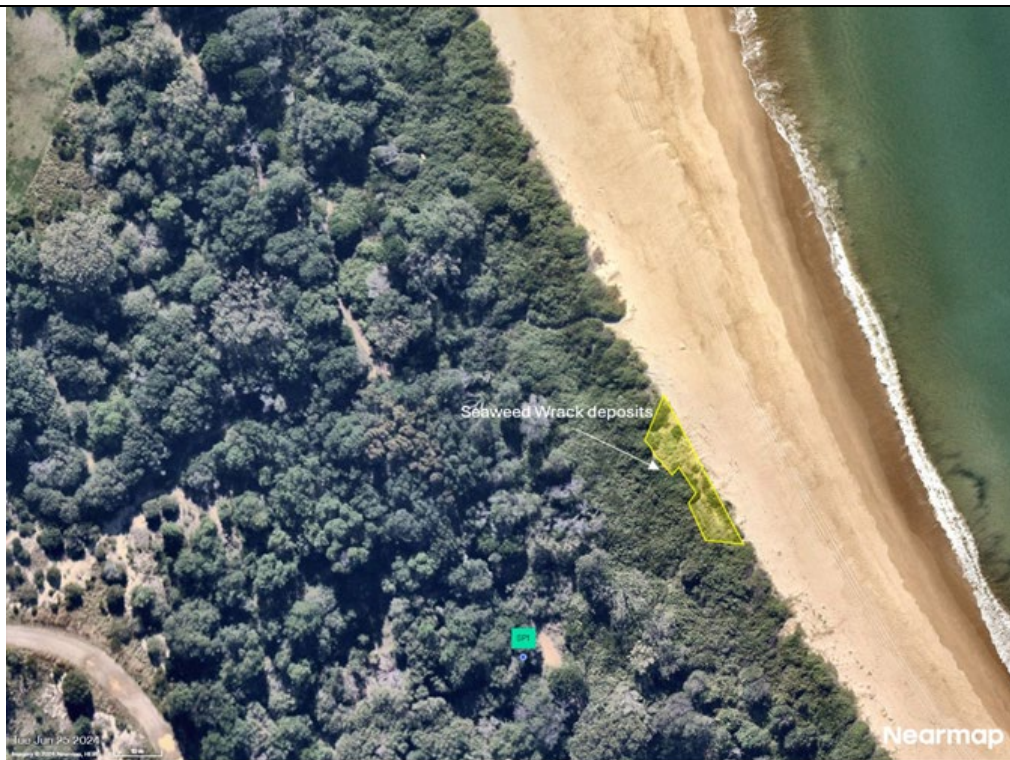
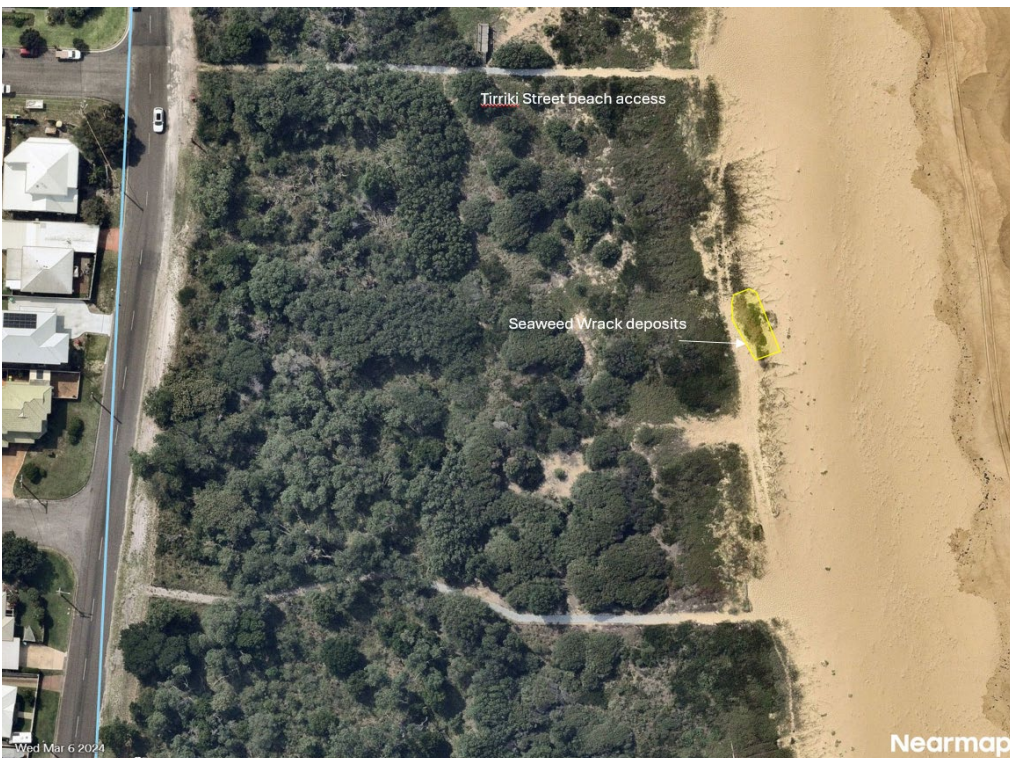
It is evident that seagrass mulch from beach scraping activities is used to infill foredune blow out areas. This was observed at two distinct areas in SP1 and SP3 and looks to be opportunistic.

Seagrass mulch (wrack) acts as a surface wind barrier while also providing structure and a rich source of organic matter within the dune. It is mixed in with aeolian sand and thickly laid with evidence of primary dune species (*Tetragonia tetragonoides*) emerging.

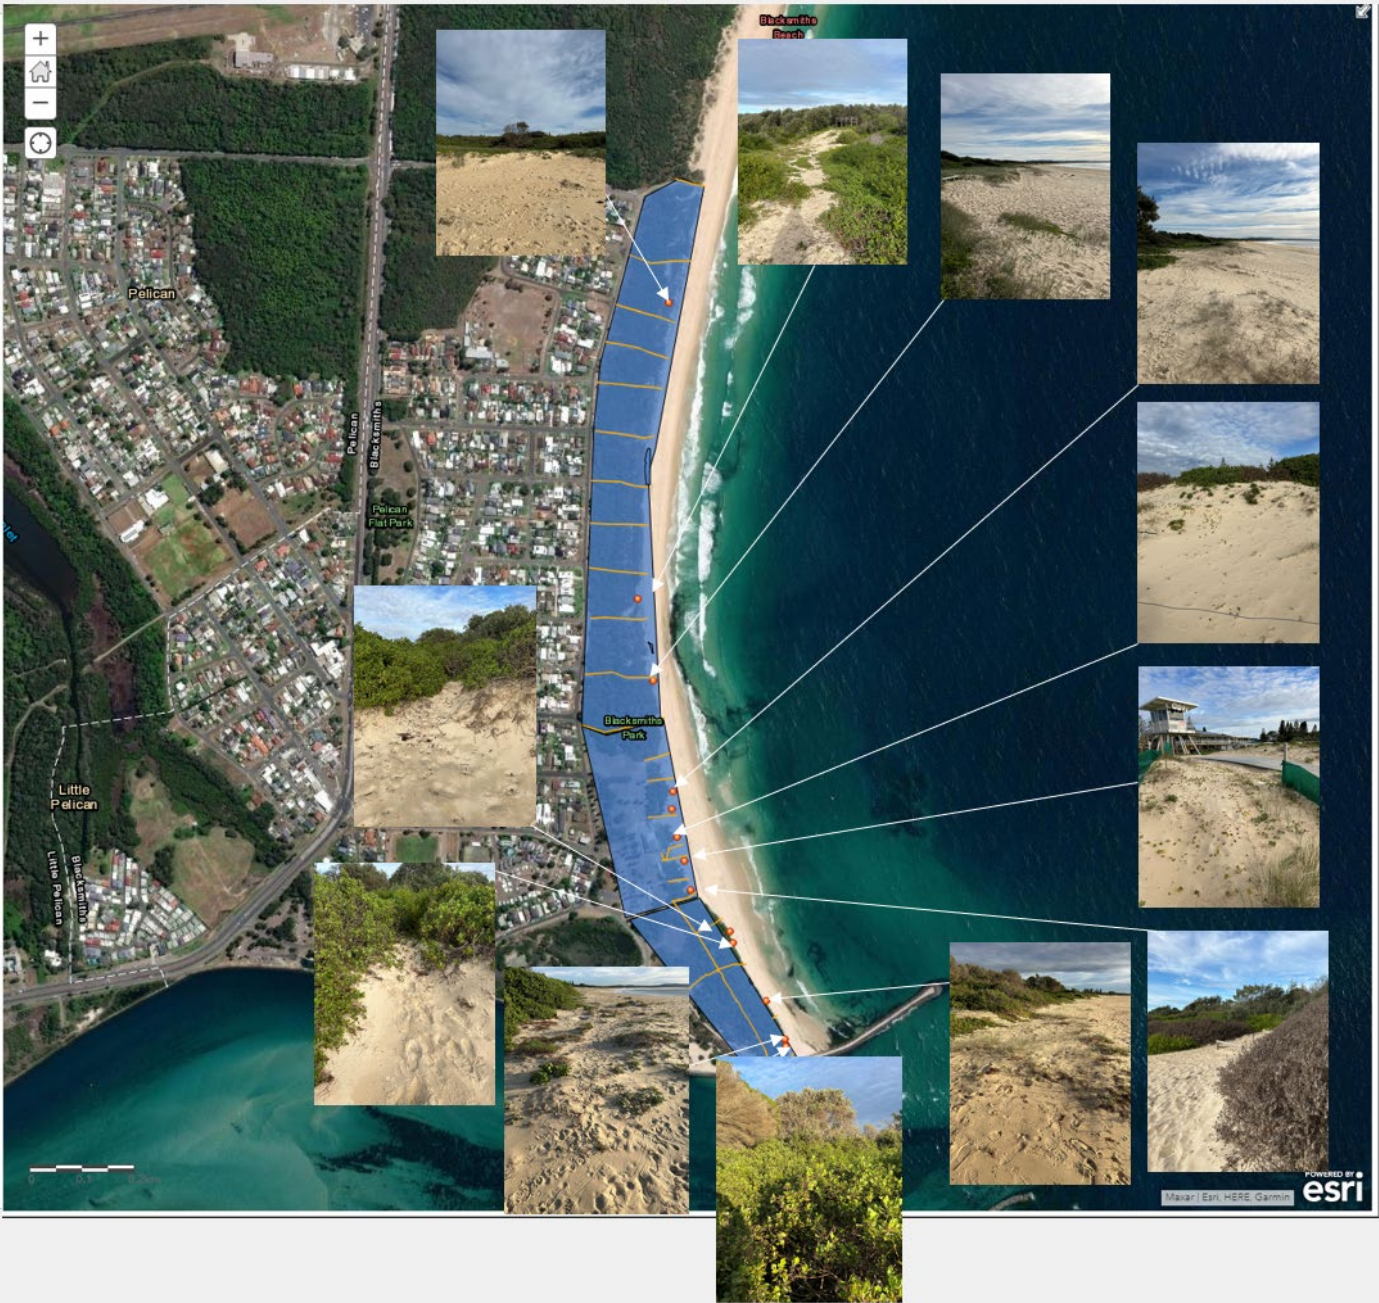
The preferred options for Dune management activities throughout the Blacksmith's Beach site are discussed. It is noted Council will engage with community on the following actions as views of management strategies are subjective to social and cultural values of the beach front. The photos below show where certain management activities could take place were captured during the site inspection. These photos highlight the southern portion (SP1 and SP2) of the study area as priority.

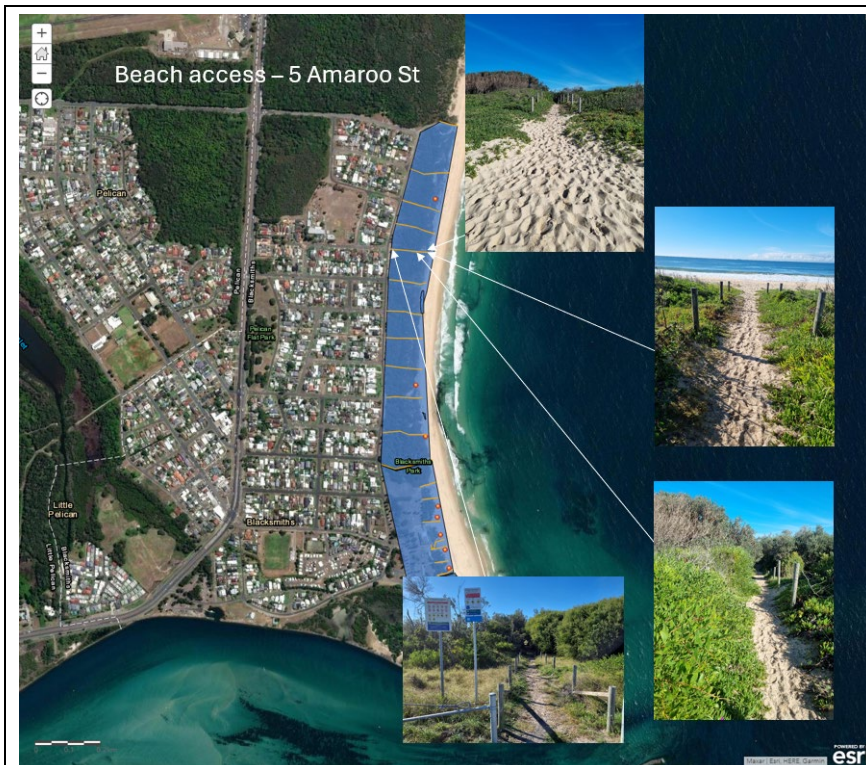
#### Track 5

Raise fencing and re-instate wires, extend at beach front by 5m and encompass crest to ensure no pedestrian access parallel to beach front on the foredune crest.

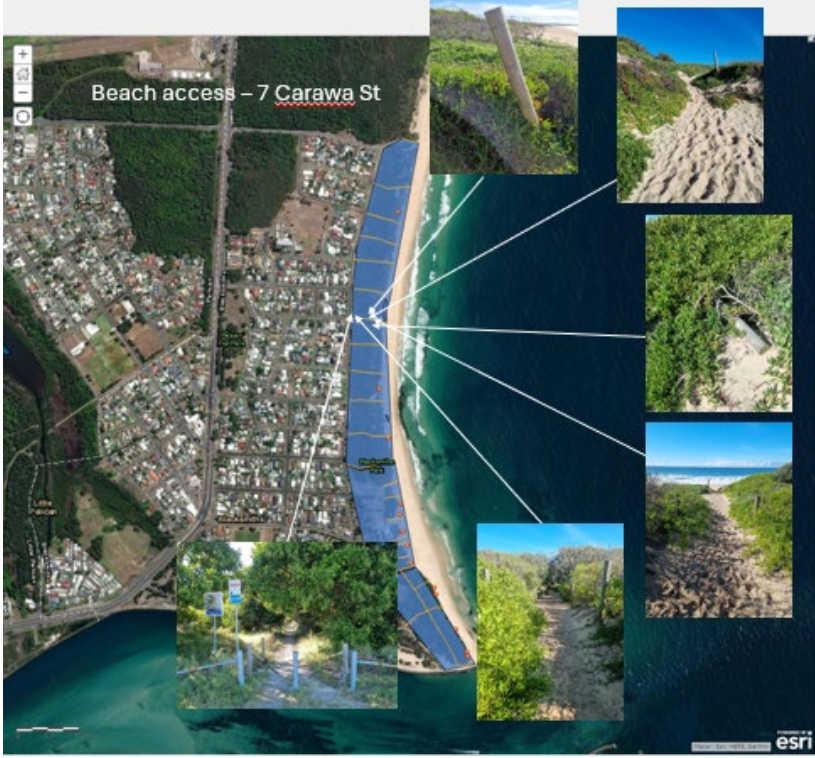
<p>Track 7</p> <p>Incised at beach front, posts need lifting and re-installing and wire replaced.</p> <p>Install T junction at beach front and infill incised areas with brush matting from track clearing.</p>
--	---

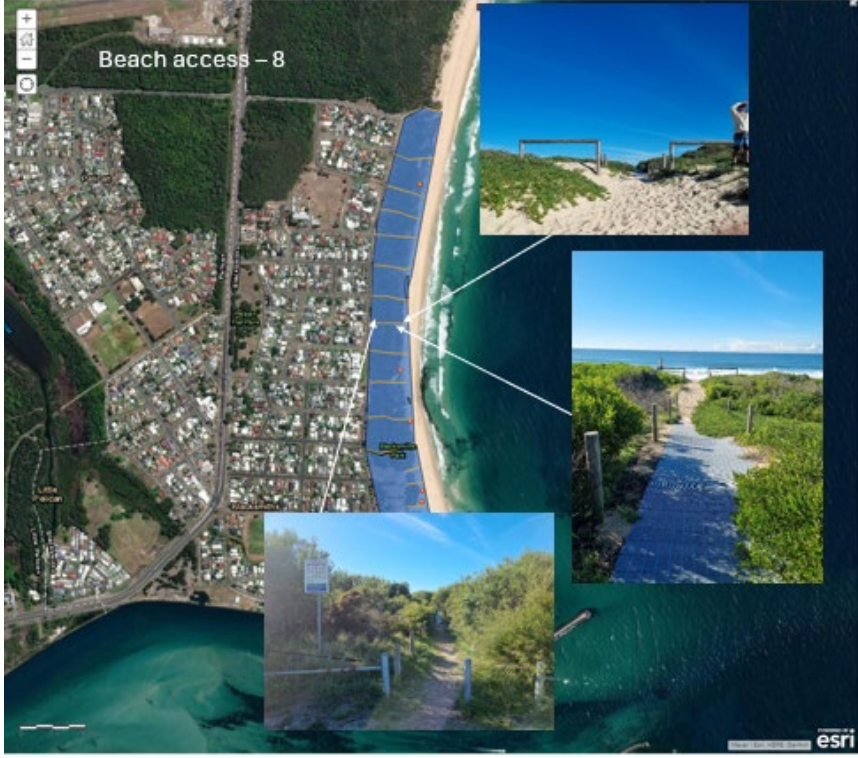
<p>Track 8</p> <p>Fencing wires need replacing, posts need lifting and re-instating.</p> <p>Brush cleared and used for infill.</p>
---	--

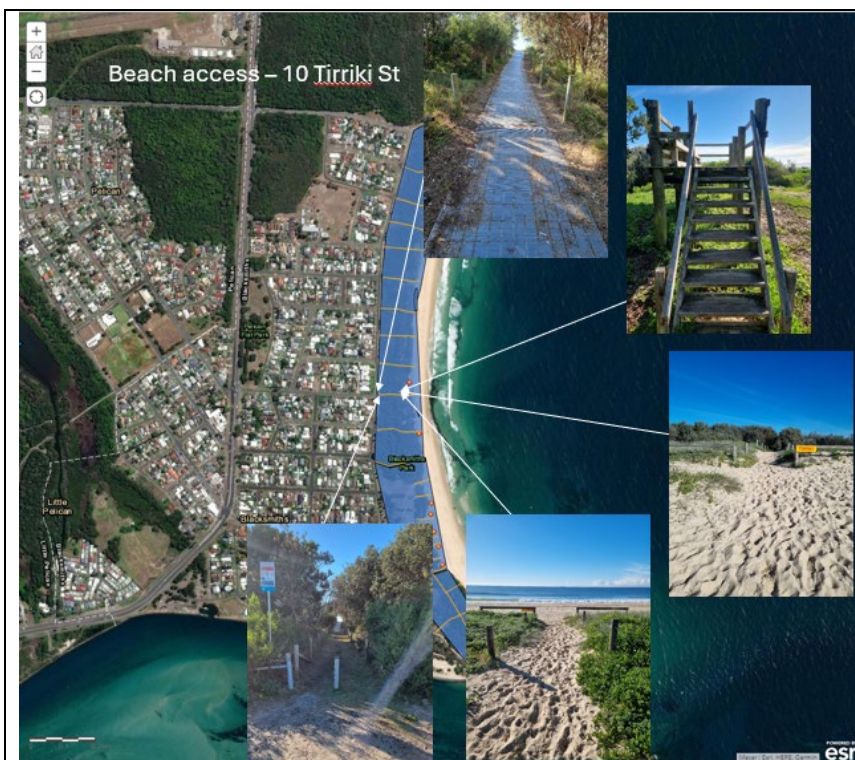
### Track 10

Posts and rails need raising on foredune, wire will also need replacing.

Brush matt northeast facing access under the lookout to minimise pedestrian activity.

Main access is to remain open and focus will be on diagonal informal access.

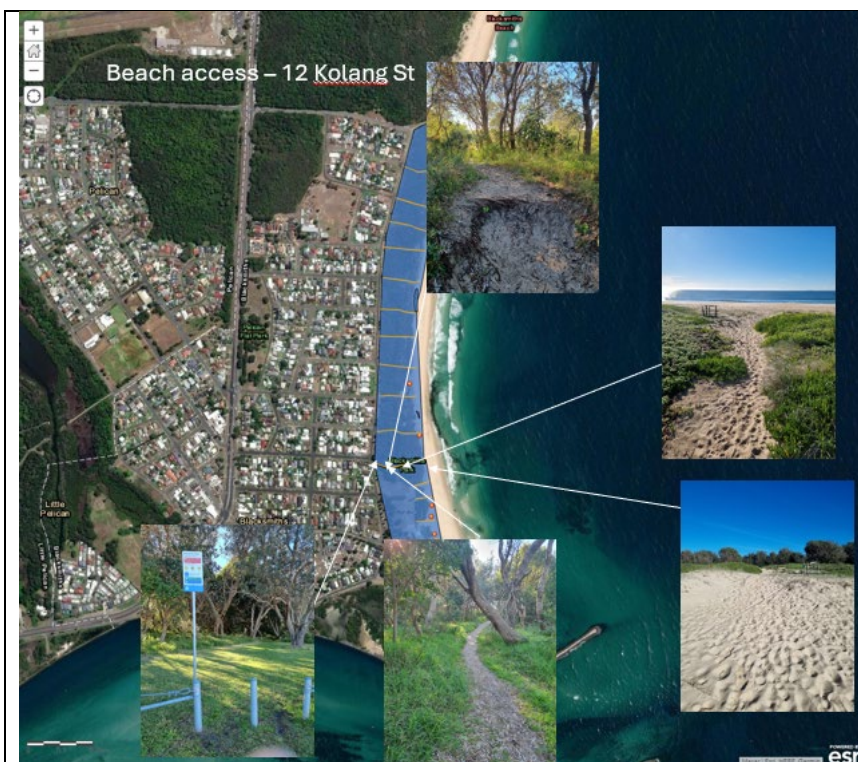
### Track 12

Incipient dune vegetation in good condition, access narrow and not well used – suggest closure by removal of signage and brush matting access.

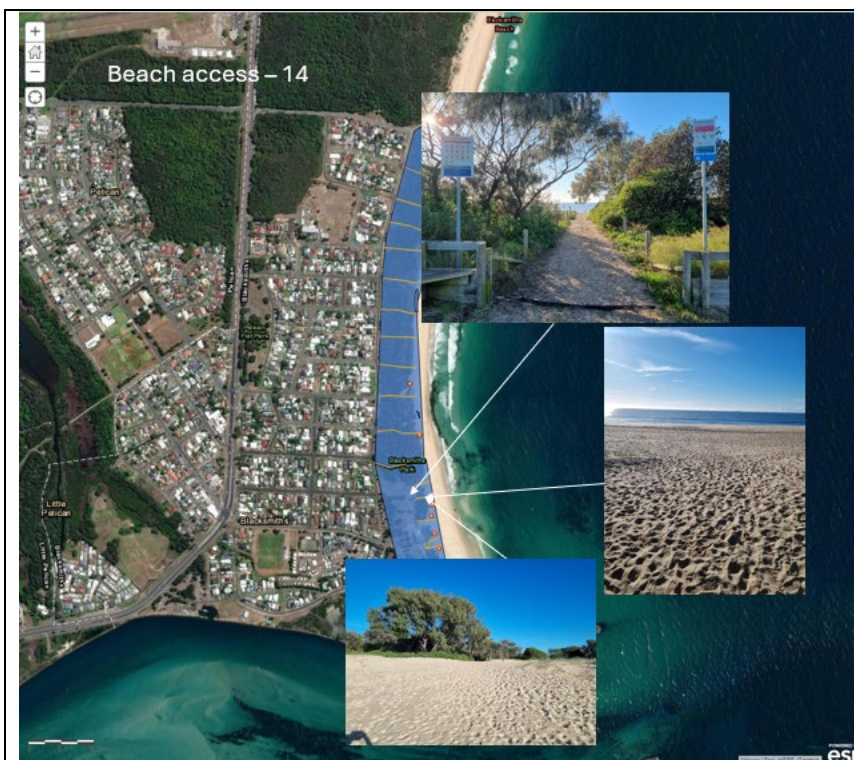
### Track 14

Extend beach-front pedestrian access fencing to ensure pedestrian activity minimised on dune crest.

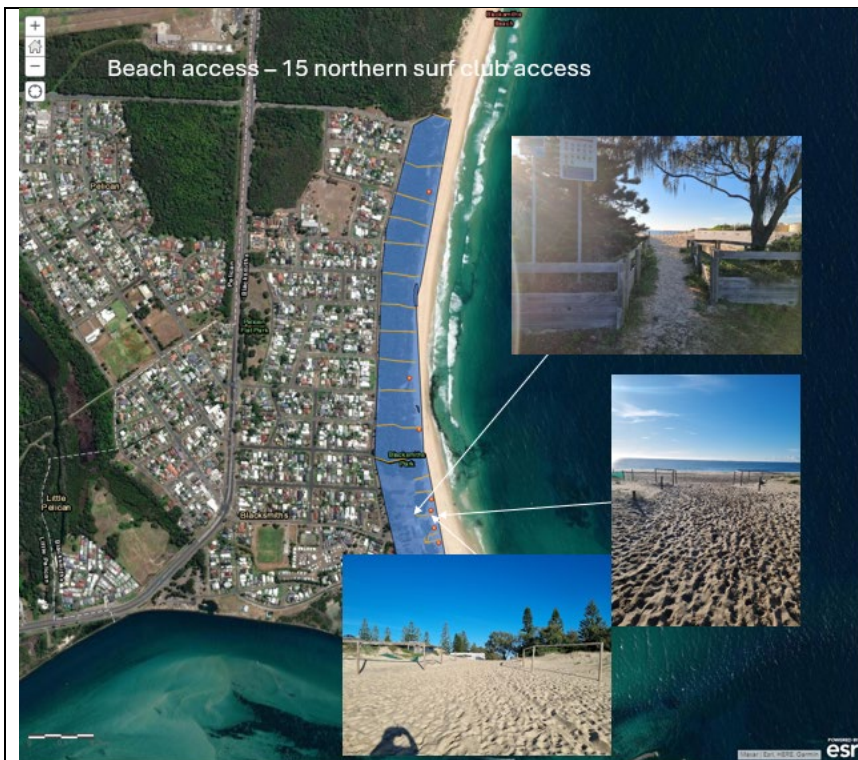
#### Track 15

Scour on north side of access at termination to beach, build up on south side. Wind fencing to be extended to capture sand.

Re-align fencing width at beach front from 6m to 3.5m to suit widest beach entry off car park to reduce build up lee side of dune crest.

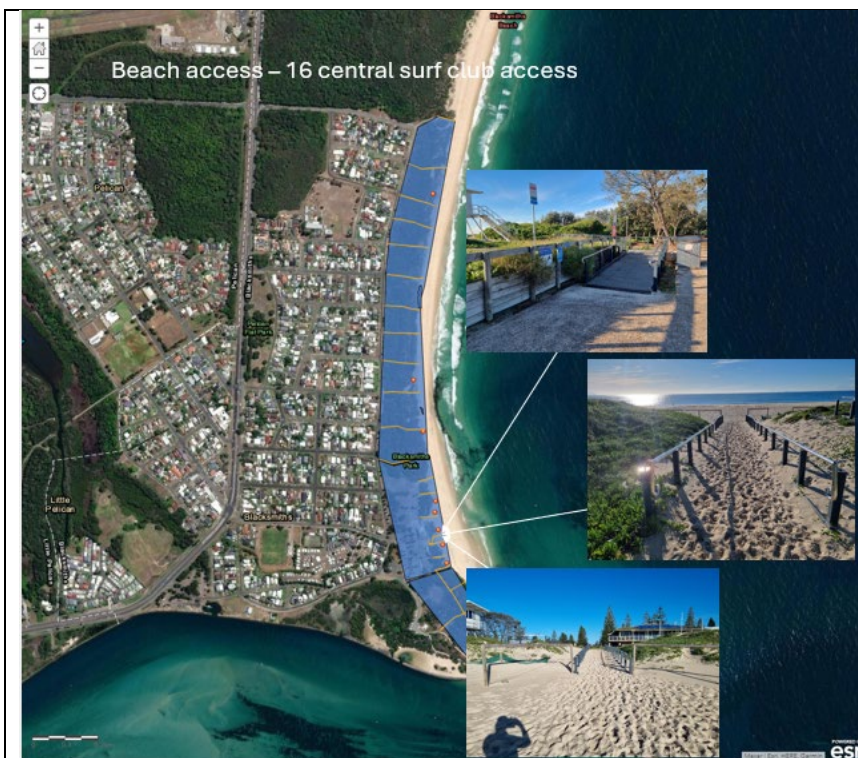
#### Track 16

Ensure sand build up is managed using machinery.

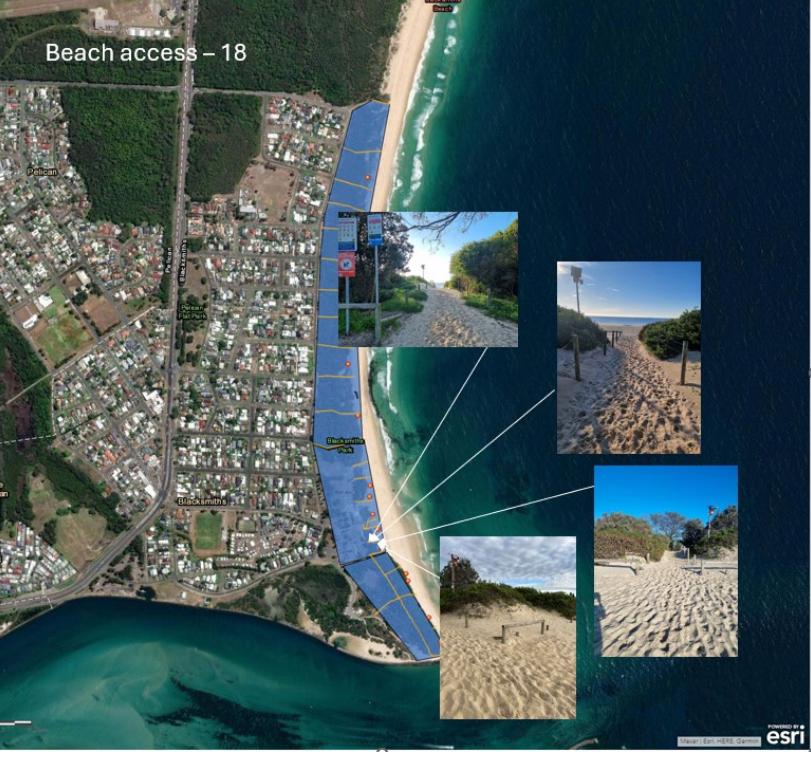
<p>Beach access – 18</p>

<p>Track 18</p> <p>Evident that north west sand migration from build-up adjacent to fence line. Fencing requires lifting and re-wiring, extend pedestrian exclusion to join southern beach front fencing. Access to memorial should be maintained.</p>
--	--

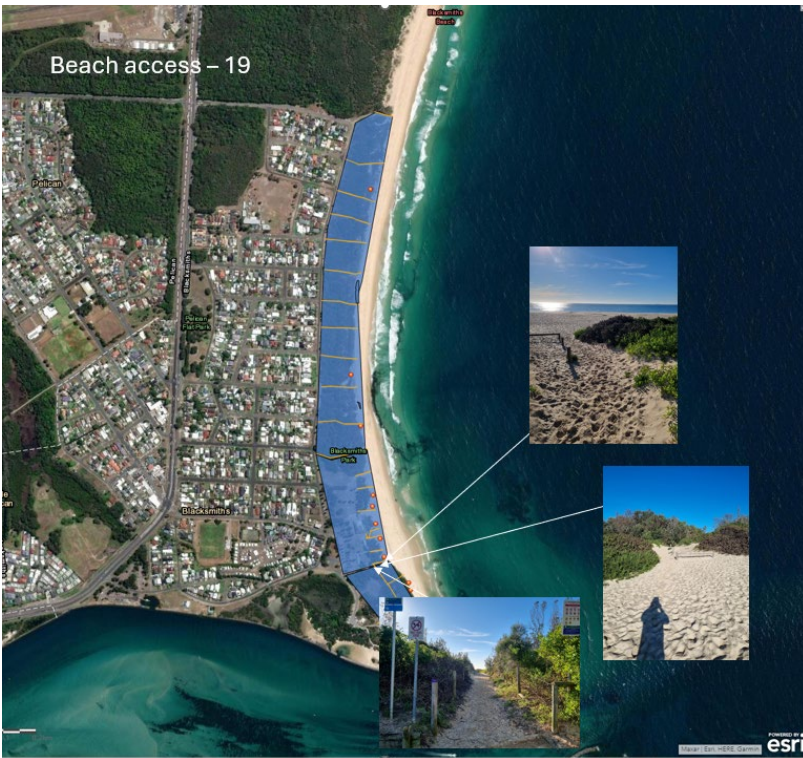
<p>Beach access – 19</p>	<p>Track 19</p> <p>Lift fencing at beach and re-wire.</p> <p>T join on north side to be maintained and left in situ – no T join on south side.</p>
---	--

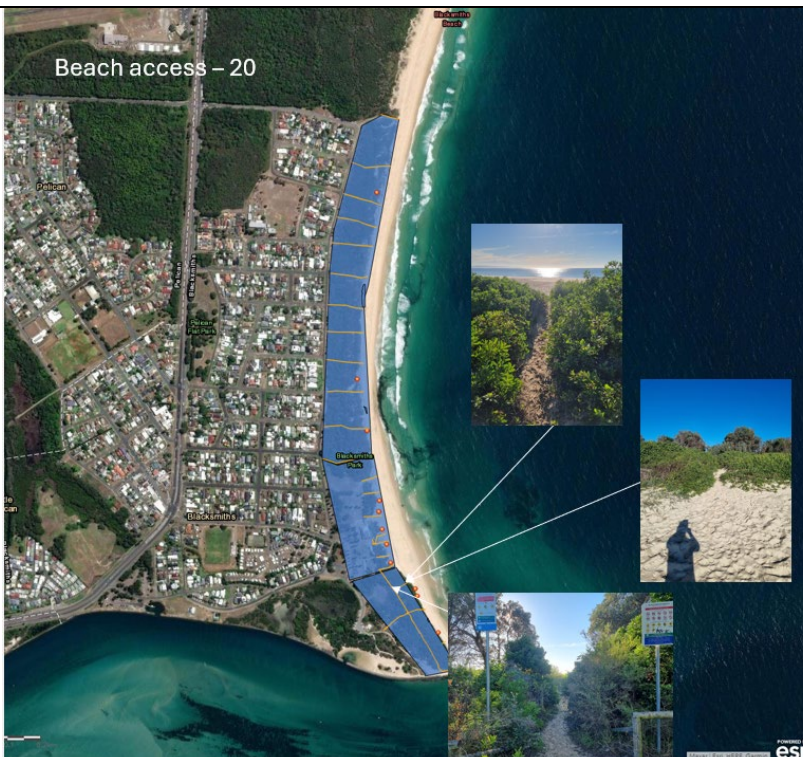
<p>Beach access – 20</p>	<p>Track 20</p> <p>Top wire needs replacing (northern side), vegetation control required.</p> <p>Utilise brush matting as proposed.</p>
--	---

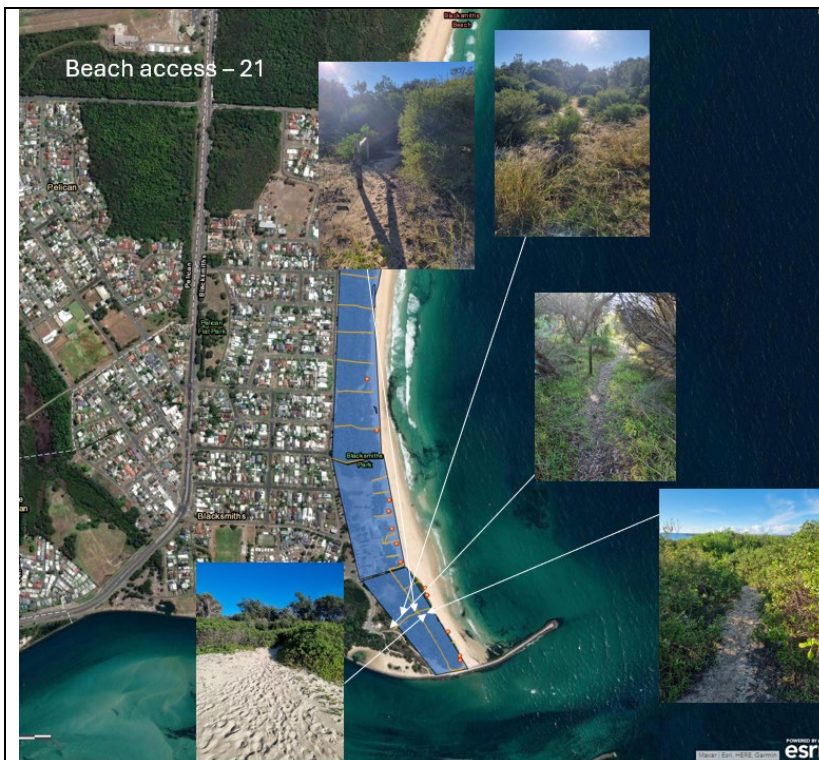
### Track 21

Replace fencing wire and undertake vegetation maintenance. Formalise access as a thoroughfare from Break wall vehicle access road. Maintain alignment with dog leg on foredune and southeast facing exit.

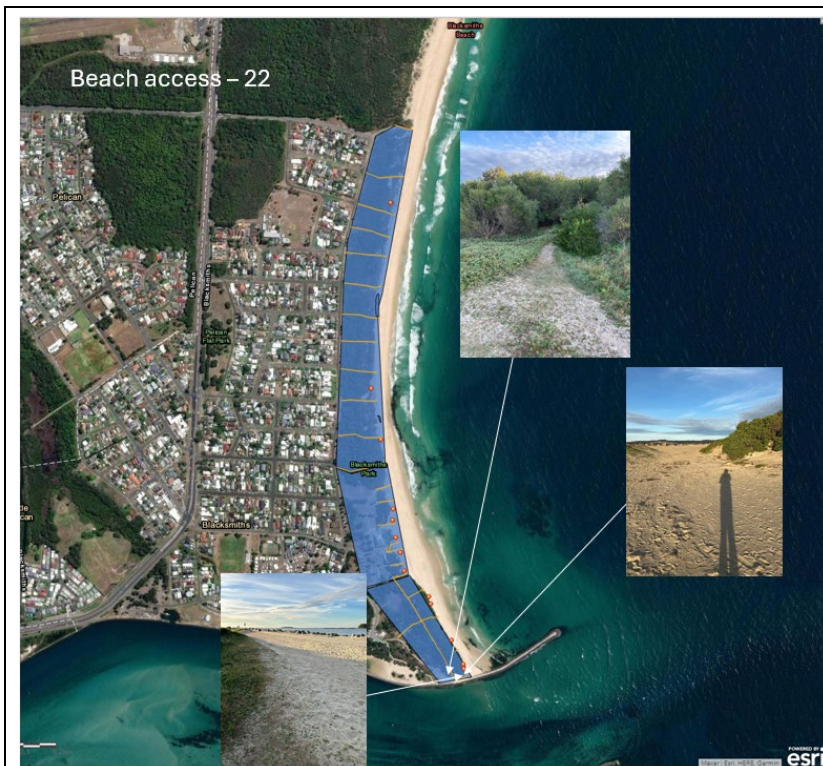
### Track 22

Vehicular access track - increase height by 300mm from beach scraping activities and install mulch covering 100mm thick.
